City of Sammamish

# **BUILDING 120 – ASSESSMENT NARRATIVE**

April 10, 2026

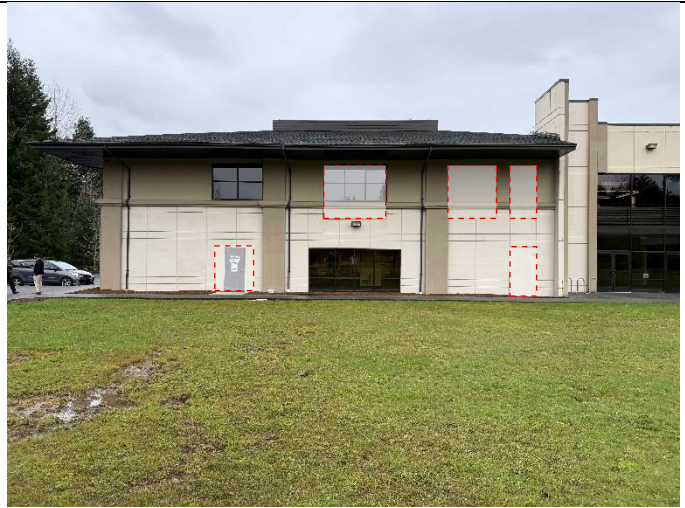
3. Consider cutting down central “L-shaped” concrete to re-shape main entry.
4. Expand sidewalk to highlight main entry.
5. Replace dark glass with visually transparent glass.

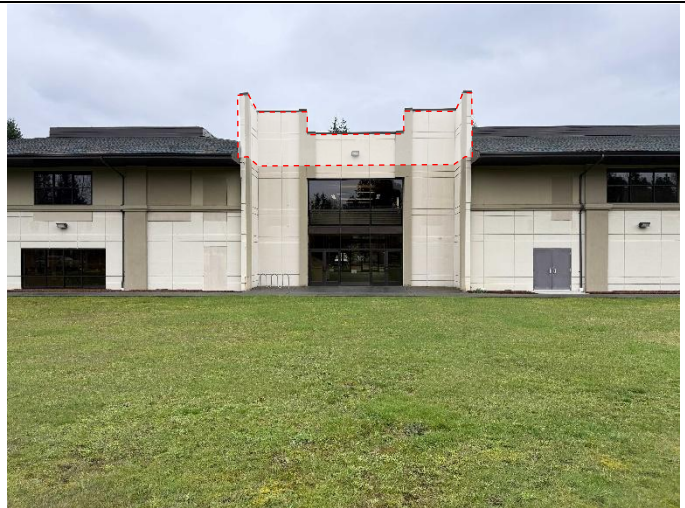
6. **Paint exterior concrete and EIFS surfaces.**

7. Consider removing “future opening” wall panels and replacing with glass.

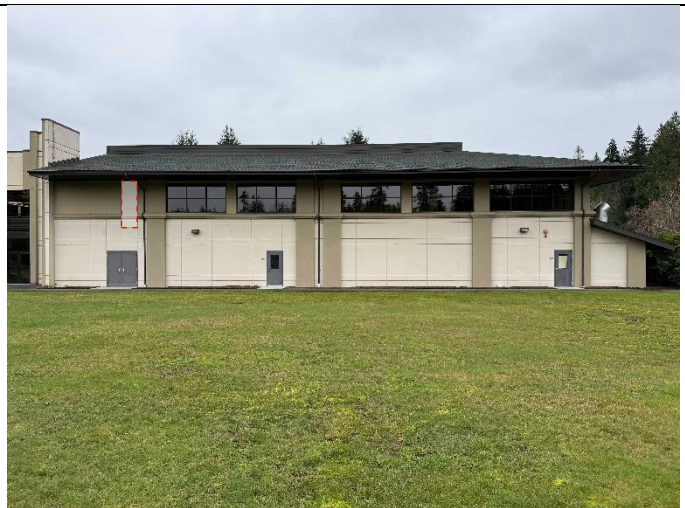
8. **Repair Exterior Insulation Finishing System (EIFS) where needed.**
9. **Clean moss from all surfaces.**

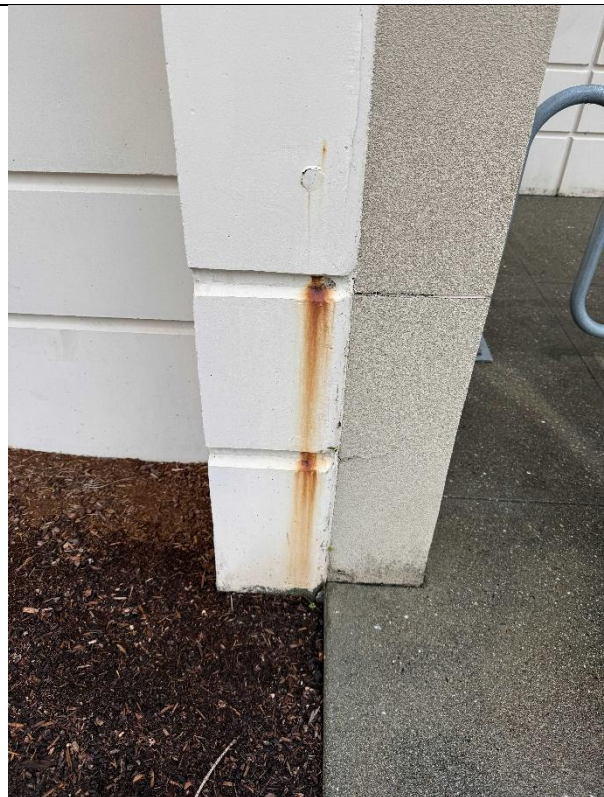
11. **Grind rusting steel, patch and repaint.**

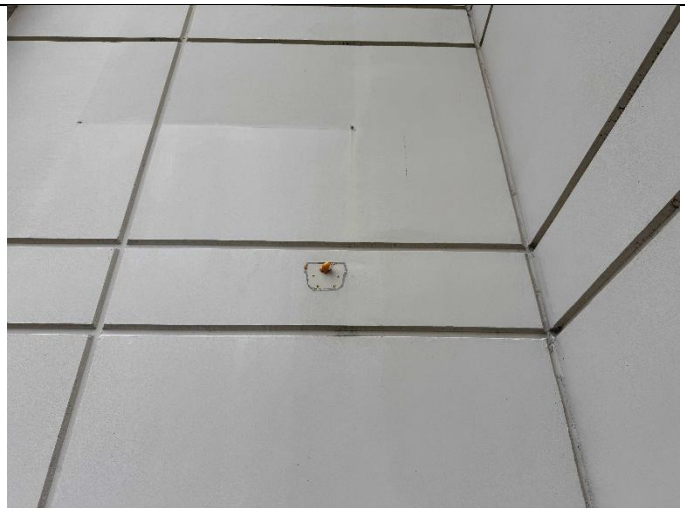
14. **Grind rusting steel plate, patch and repaint.**

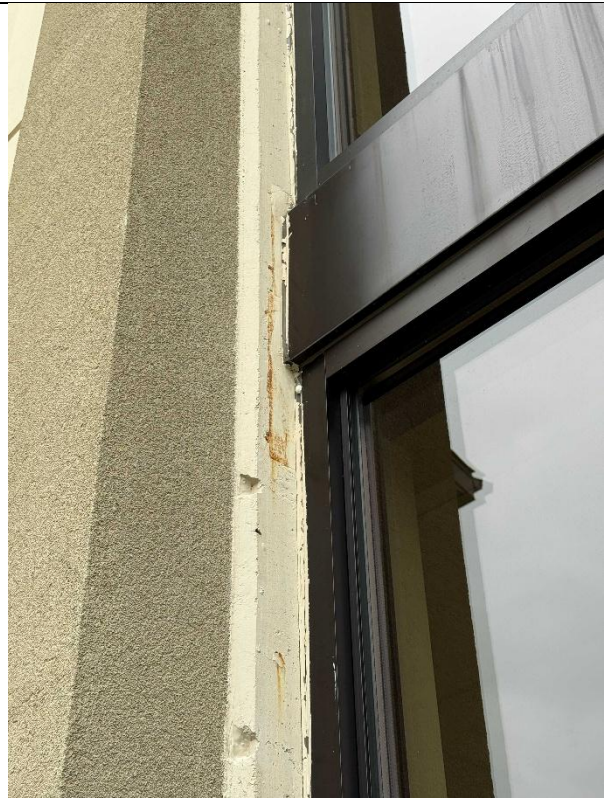
15. **Clean paint from caulk between concrete panels.**  
16. **Re-caulk where necessary (assume 50%)**

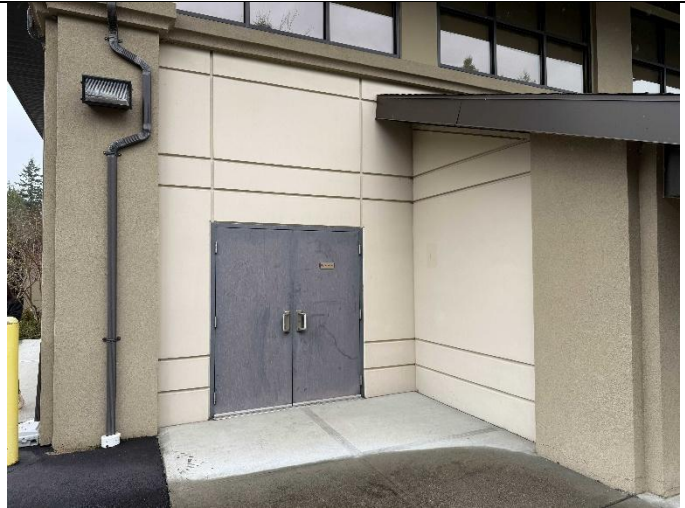
21. **Paint all exterior doors with high performance gloss paint.**

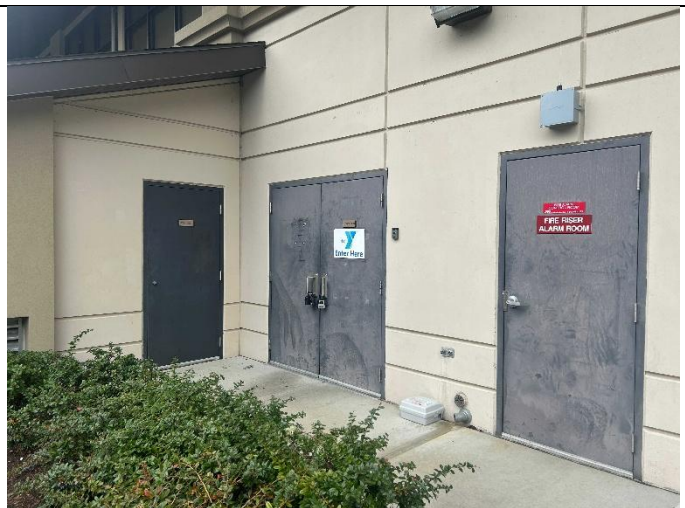
- 22. Replace hardware with appropriate access control hardware.
- 23. **Sand and paint all hollow metal doors.**

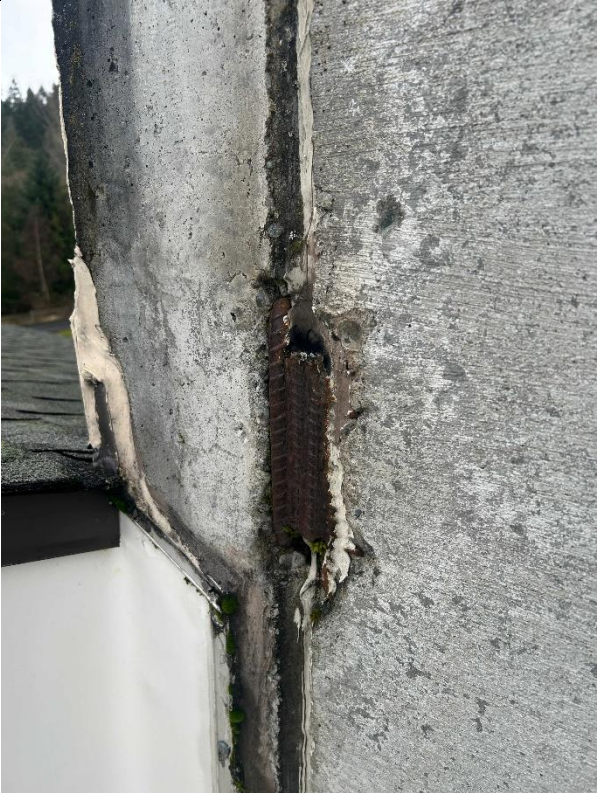
| <p>38. <b>Where concrete panels remain, clean and seal joint.</b></p> <p>39. <b>Protect exposed steel from further rusting.</b></p> | A close-up photograph showing a vertical joint in a concrete wall. The joint is filled with a dark, textured material, possibly sealant or grout. A vertical steel reinforcement bar is visible, showing significant rust and corrosion. The concrete surface is weathered and discolored. |

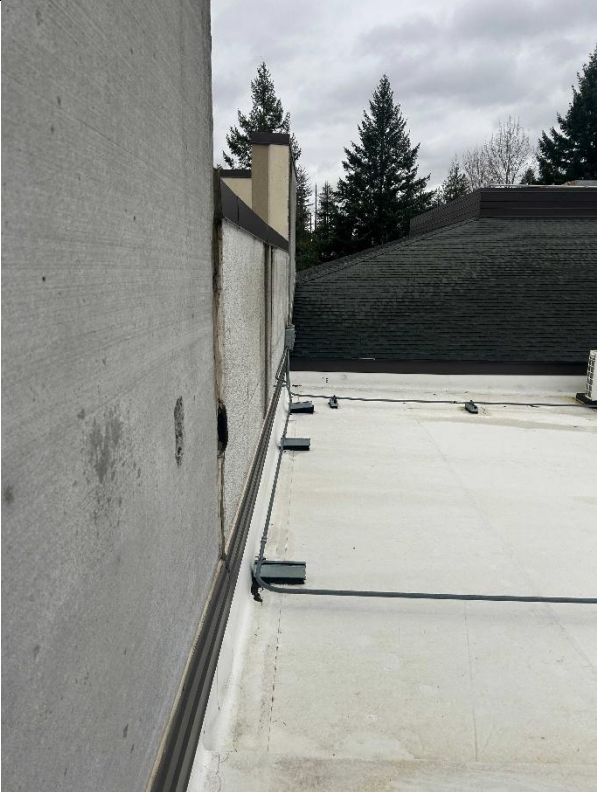
| <p>40. <b>Provide water repellent coating at exposed concrete.</b></p> | A photograph showing a concrete wall and a roofline. The wall is light-colored and appears to be made of concrete panels. The roof is dark and has a gabled section. The sky is overcast and grey. The image shows the area where a water repellent coating would be applied to the concrete wall. |

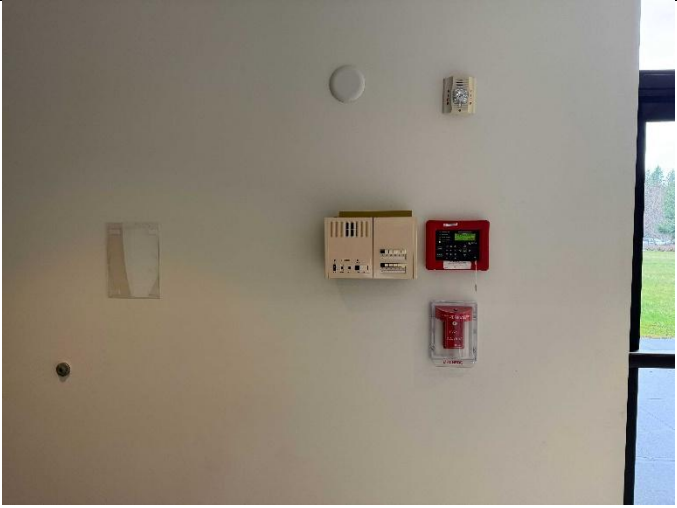
| <p>11. <b>Remove antiquated control / communication boxes. Patch and repair walls.</b></p> | |

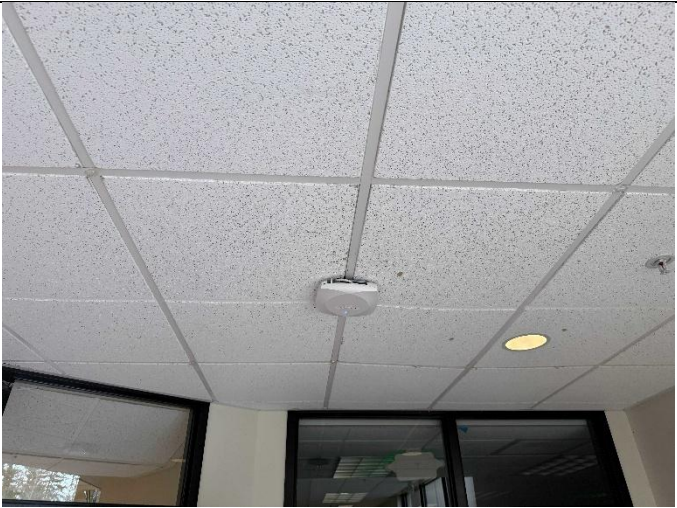
| <p>12. <b>Repair or replace sagging ACT panels everywhere.</b></p> <p>13. Replace lamps in all recessed cans fixtures throughout with 3000K LED lamps.</p> | |

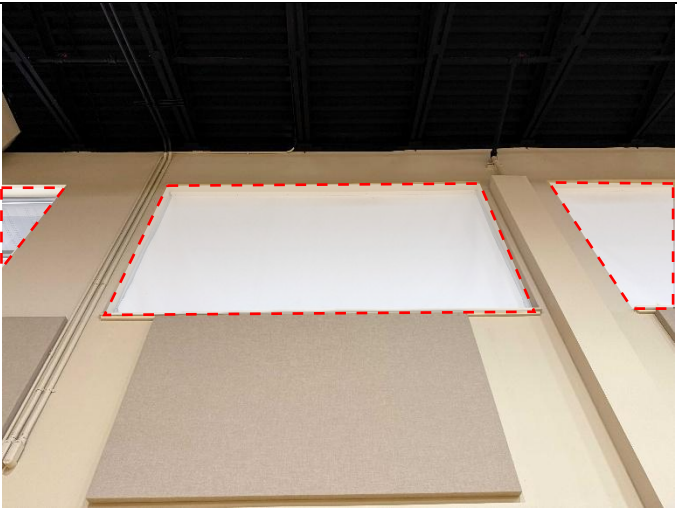
| <p>21. <b>Replace fixed window shades with motorized roller shades, 1% openness.</b></p> | |

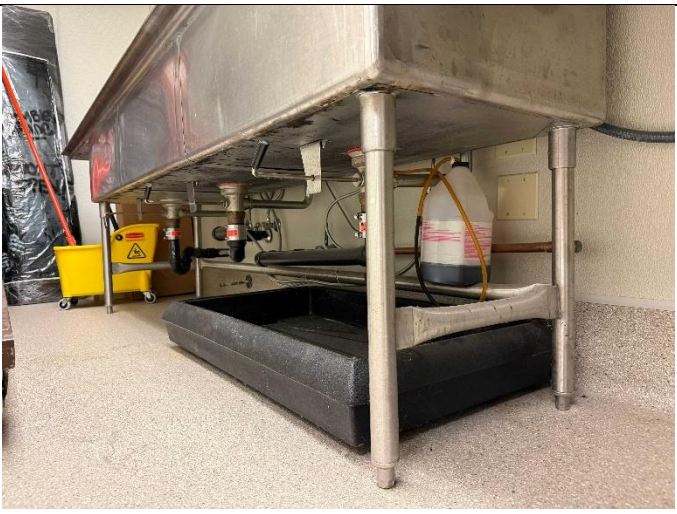
| <p>36. <b>Add a 2,500-gallon grease trap.</b></p> <p>37. <b>Provide code compliant air gaps at food service sinks.</b></p> | |

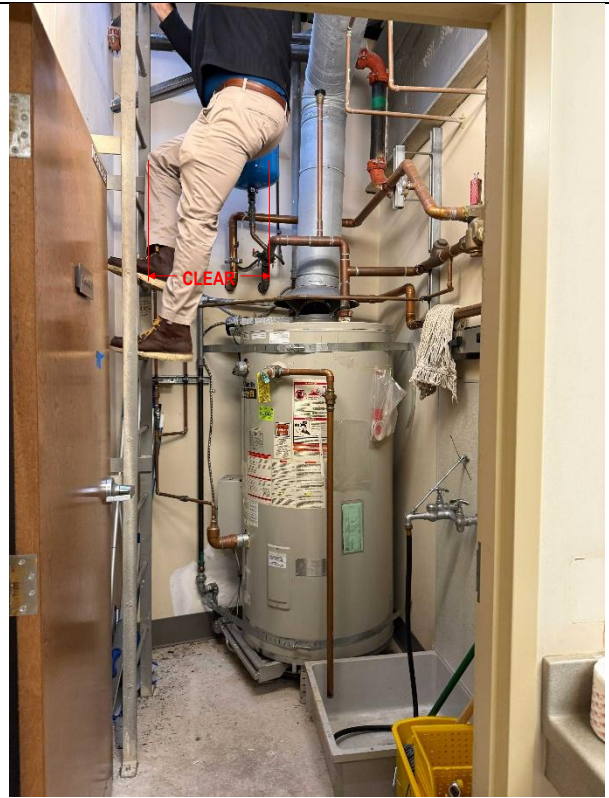
South roof access is via a 12-ft high ladder in a janitor closet connected to the men's restroom.. A water heater intrudes on the safe climbing area creating unsafe conditions. Consider moving the water heater. The roof hatch and opening protection seem adequate.

- 86. **Replace water heater in location that allows safe passage up ladder.**
- 87. **Deep clean floor.**

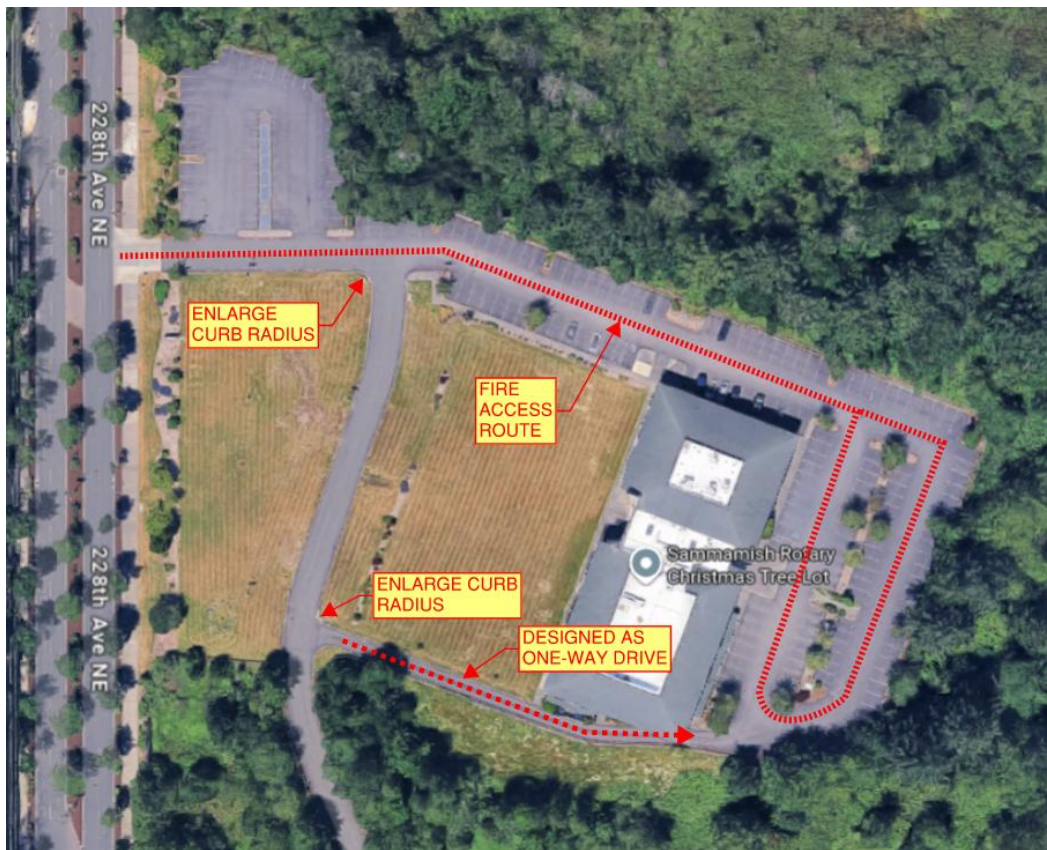
**Figure 1.** Site Hardscape and Recommended Improvements Locations (north is page up).

Existing cement concrete curbing has been broken by vehicular impacts at two primary locations. Large concrete blocks have been positioned behind the curb at each of these locations to deter drivers from impacting the curb; however, the existing curb radii are smaller than is typical to

1. Enlarge Turning Radii at Two Corners: Rebuild existing asphalt pavement and concrete curbing to create larger radius turns at two locations. See Figure 1. Estimated material quantities are 360 linear feet of cement concrete curb and 20 square yards of asphalt pavement. The existing asphalt pavement section is 2 inches of hot mix asphalt over 4 inches of crushed surfacing base course over compacted subgrade.

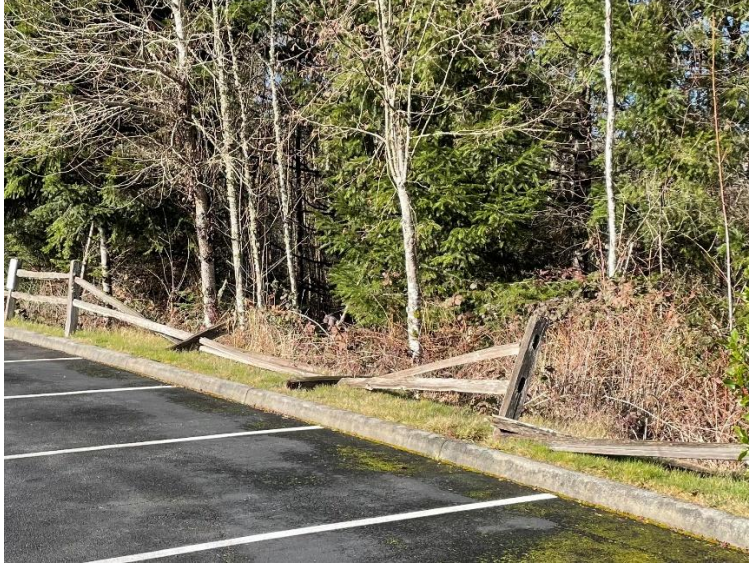
A significant portion of the site is wetland area, with a split rail fence along its edge. Approximately 160 linear feet of the split rail fence is in need of repair, which would be a baseline cost. It is also noted that the wetland area appears to be degraded with invasive species. Enhancement of the wetland area is recommended but not included in the baseline work costing.

*Example of fence damage*

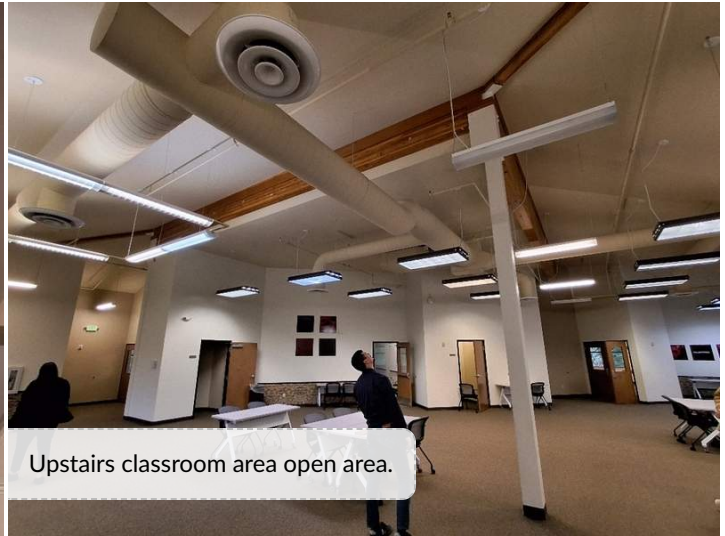
High noise levels were observed in this area (typ of both classrooms). It is believed the sound is due to the diffuser coming directly off the main drop.
