Sammamish Basin Plans

APPENDIX D

Photo Logs

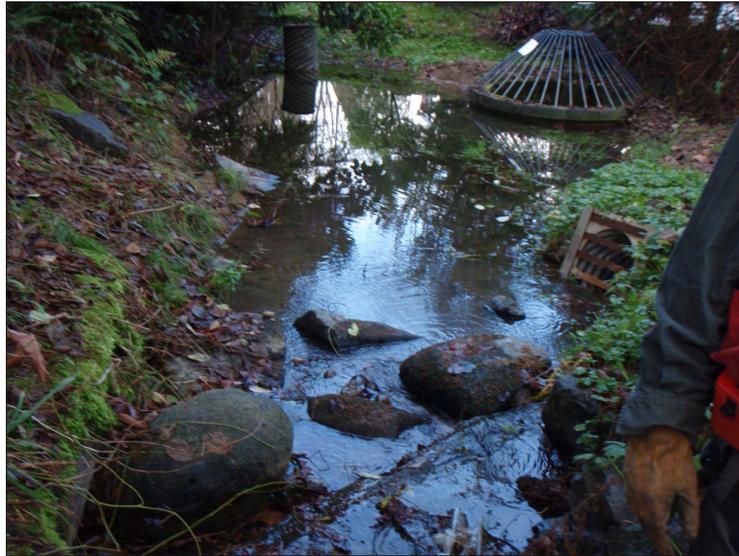
Station 1. George Davis Creek 150 feet upstream from East Lake Sammamish Parkway.

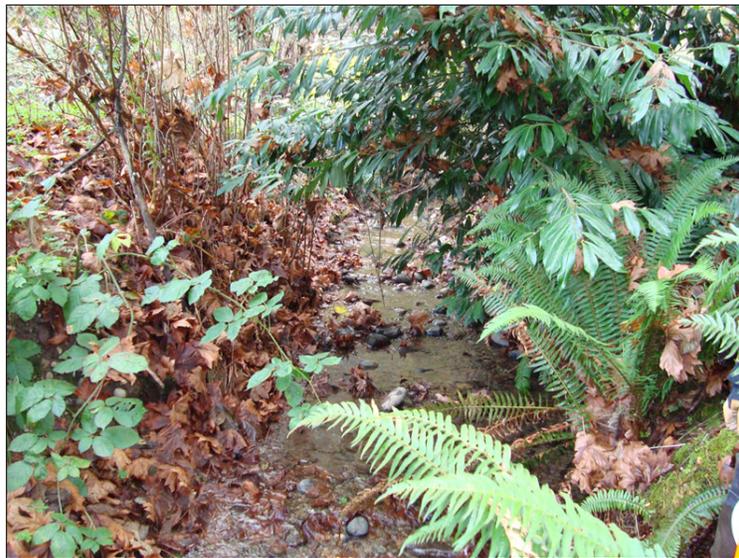
Station 2. George Davis Creek 250 feet upstream of East Lake Sammamish Parkway.

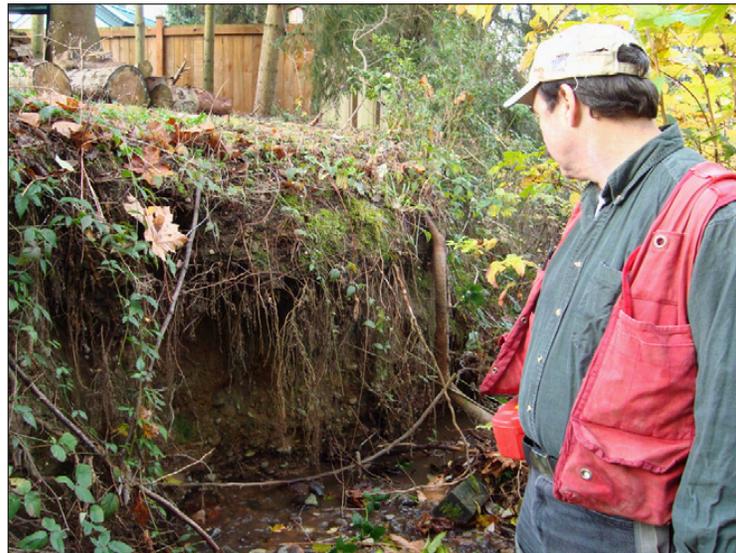
Station 3. Bank erosion and stream downcutting on George Davis Creek 300 feet upstream of East Lake Sammamish Parkway.

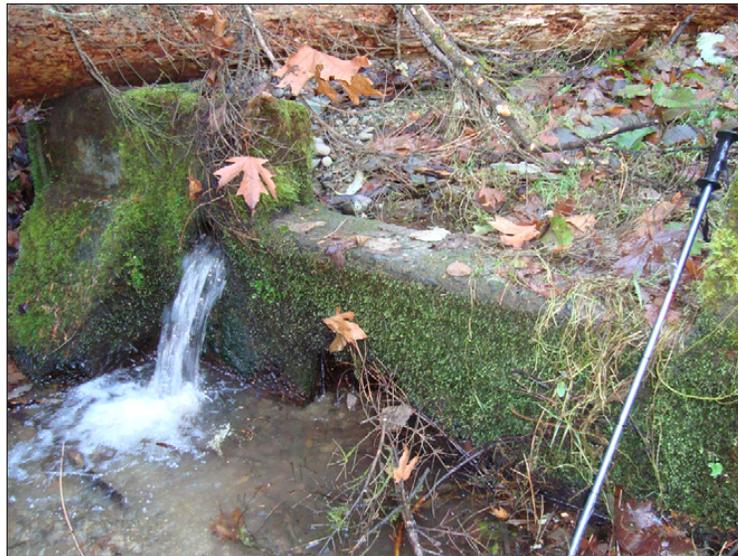
Station 6. George Davis Creek 635 feet upstream from East Lake Sammamish Parkway.
(note: old water supply dam)

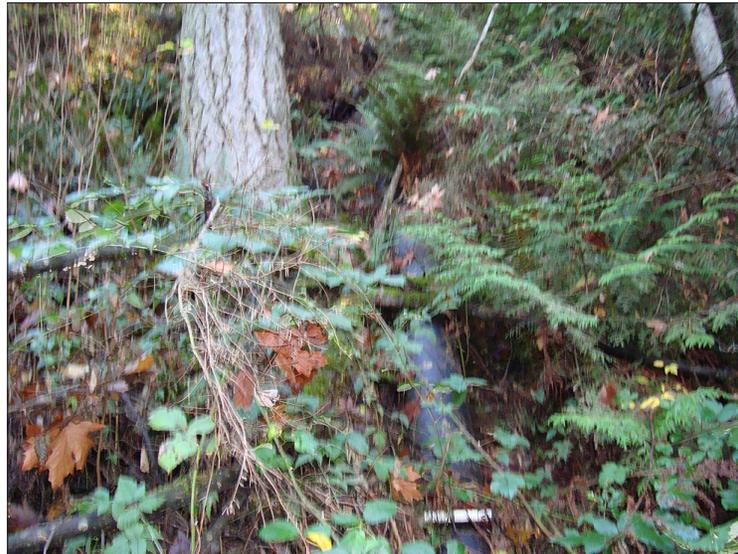
Station 7. Stormwater pipe and outfall on right bank of George Davis Creek 680 feet upstream of East Lake Sammamish Parkway.

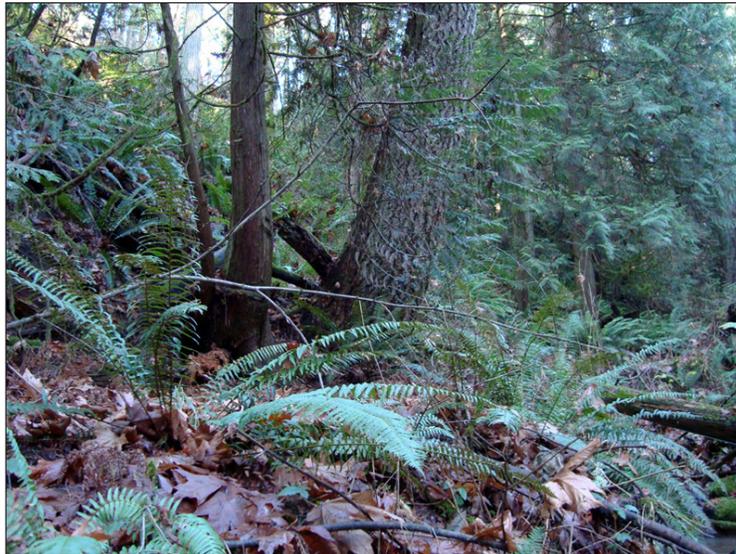
Station 9. Old road bed on right bank of George Davis Creek 800 feet upstream of East Lake Sammamish Parkway.

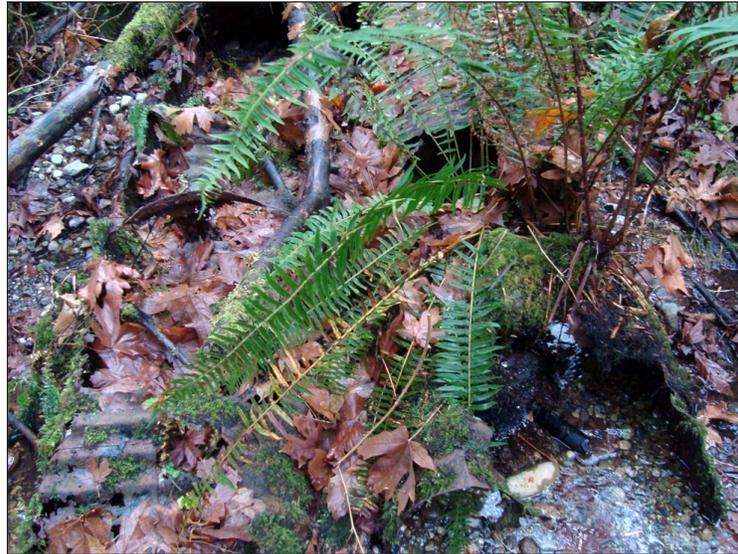
Station 15. George Davis Creek in old culverts 1200 feet upstream of East Lake Sammamish Parkway.

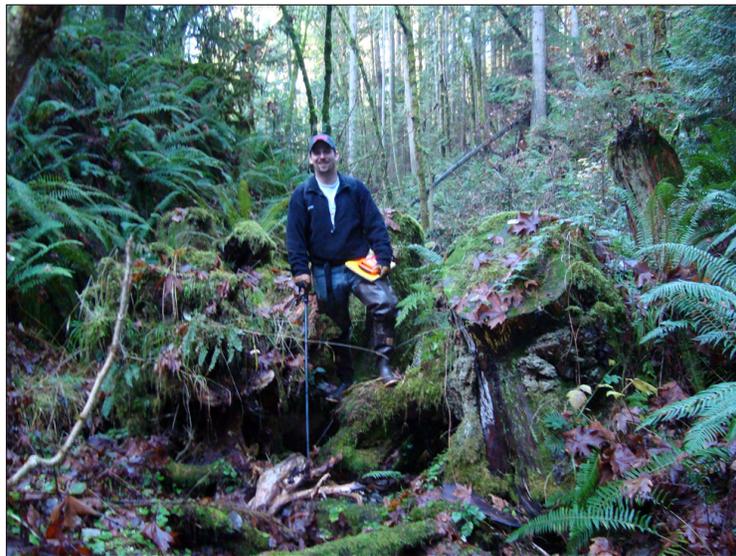
Station 20. George Davis Creek 2850 feet upstream from Lake Sammamish Parkway.
(note: one of a number of root-wad flow control structures in the creek)

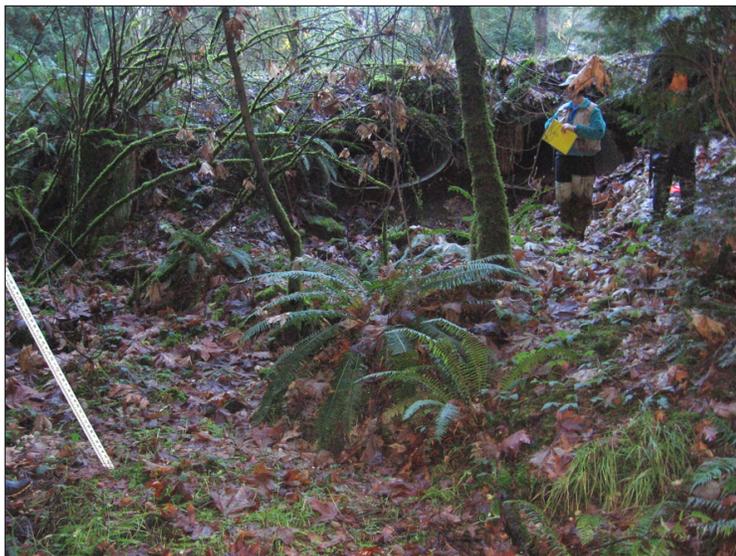
Station 26. George Davis Creek 4200 feet upstream from Lake Sammamish Parkway.
(note: dual 5-foot diameter culverts under NE 6th Street)

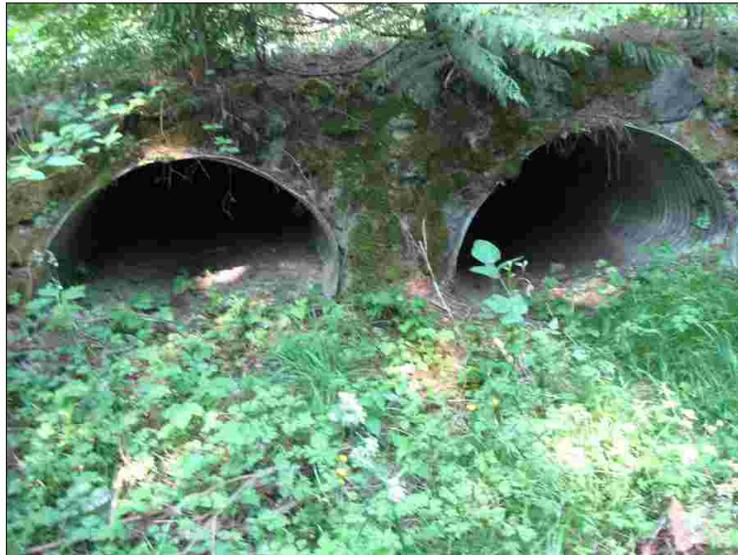
Station 27. George Davis Creek 4800 feet upstream from Lake Sammamish Parkway
(note dual 6-foot wide by 3-foot tall culverts under 216th Ave NE)

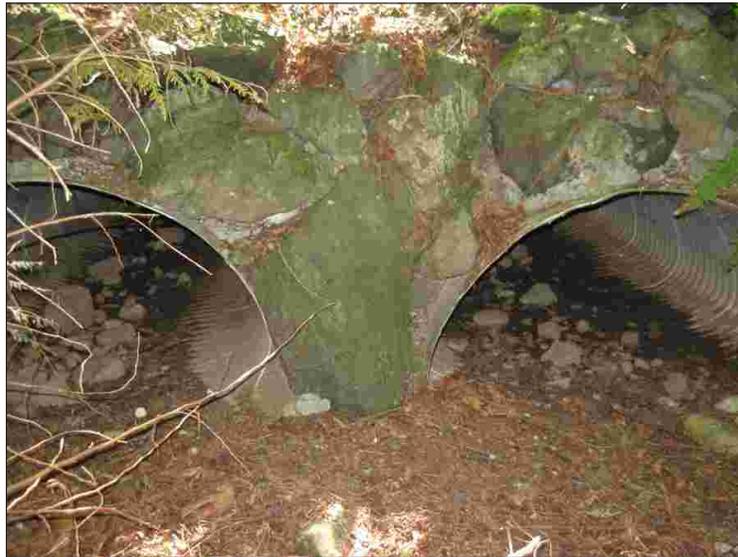
Station 29. George Davis Creek 5000 feet upstream from Lake Sammamish Parkway
(note dual 6-foot wide by 3-foot tall culverts under 218th Ave NE)

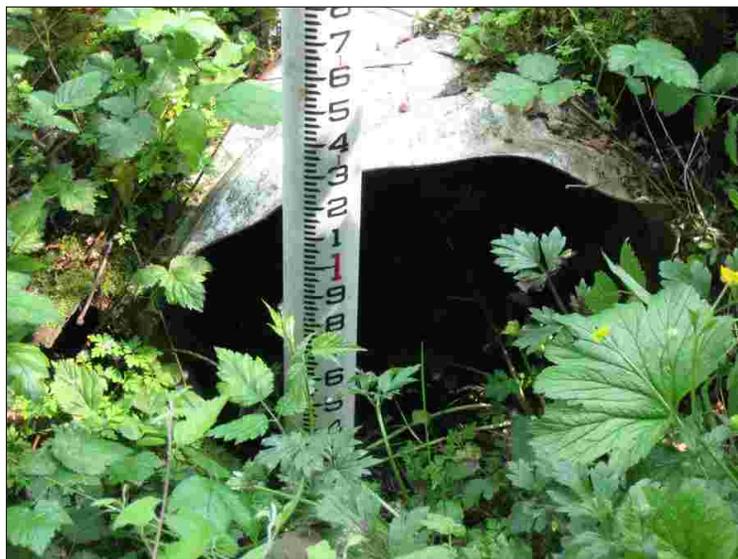
Station 32. Right bank stormwater outfall 5375 feet upstream from Lake Sammamish Parkway

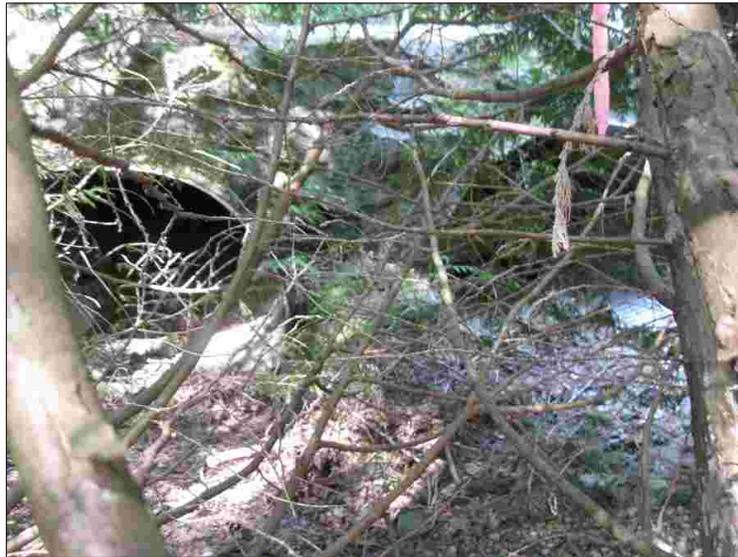
Station 33. George Davis Creek 5530 feet upstream from Lake Sammamish Parkway
(note dual 6-foot wide by 3-foot tall culverts under 219th Ave NE)

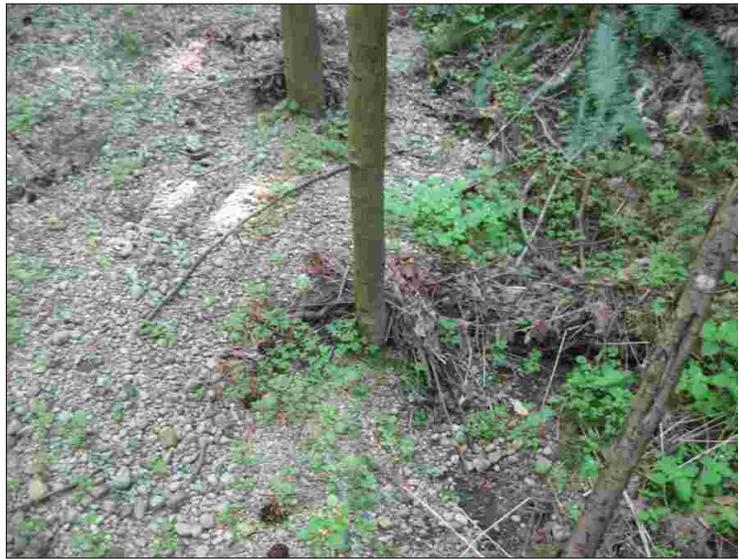
Station 35. Scour at tree roots 5660 feet upstream from Lake Sammamish Parkway

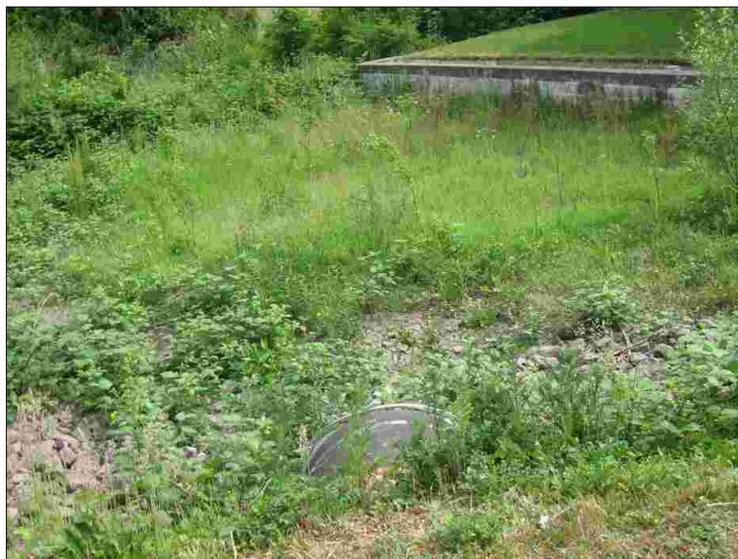
Station 38. George Davis Creek 6500 feet upstream from Lake Sammamish Parkway
(36" CMP outfall of South Branch of George Davis Creek on 222nd Ave NE)

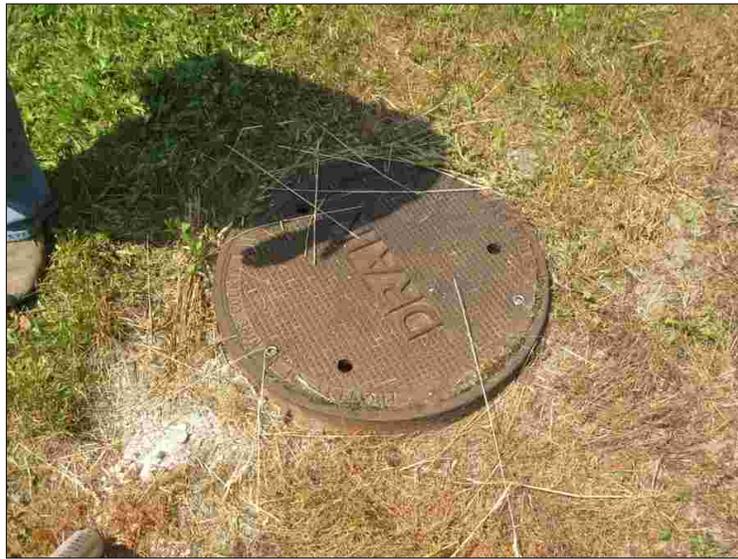
Station 39. George Davis Creek 7215 feet upstream from Lake Sammamish Parkway (South Branch of George Davis Creek in storm drain)

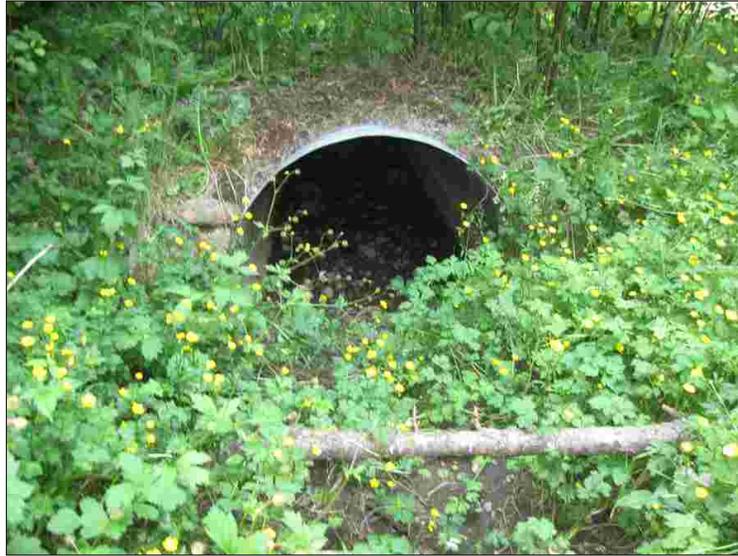
Station 41. George Davis Creek 8800 feet upstream from Lake Sammamish Parkway (culvert for South Branch of George Davis Creek on NE 2nd St)

PROJECT DESCRIPTION: Remove three existing culverts beneath the driveway at NE 2nd St and 223rd Place. Install a precast concrete box culver with stream bed. Replace the driveway.

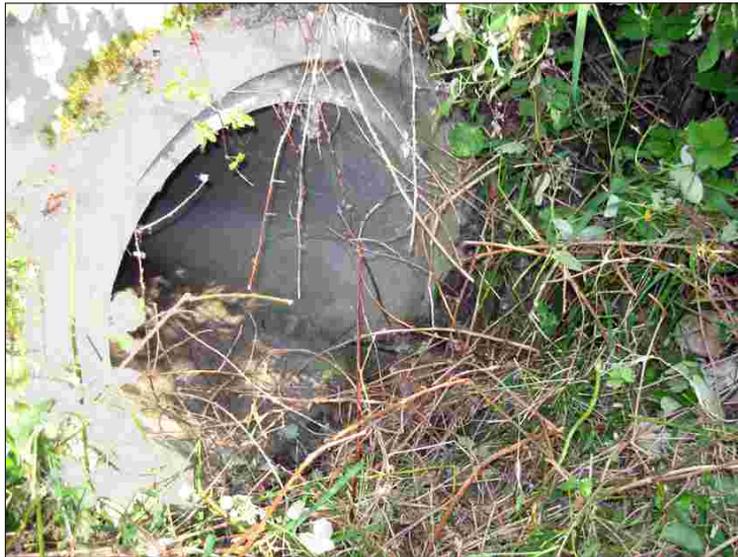
Station 51. South Branch of George Davis Creek 13,000 feet upstream from Lake Sammamish Parkway (Culvert inlet at 228th Ave SE)

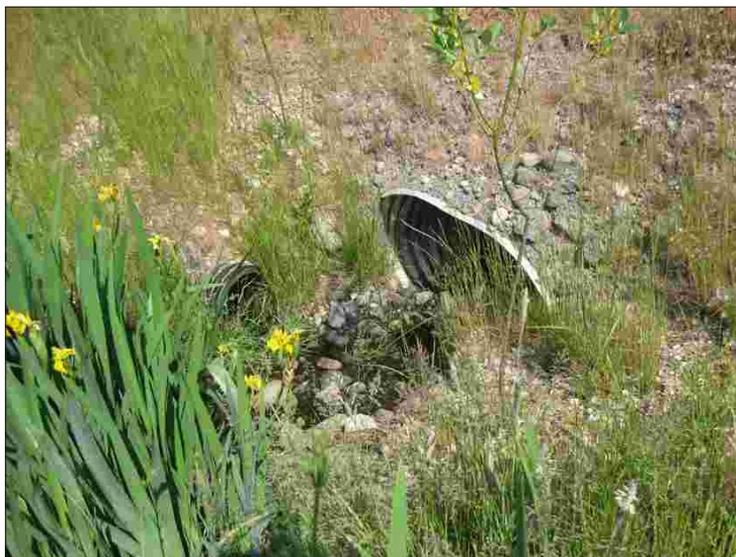
Station 56. South Branch of George Davis Creek 13,775 feet upstream from Lake Sammamish Parkway (36" culvert inlet in wetland; 12" culvert from pond)

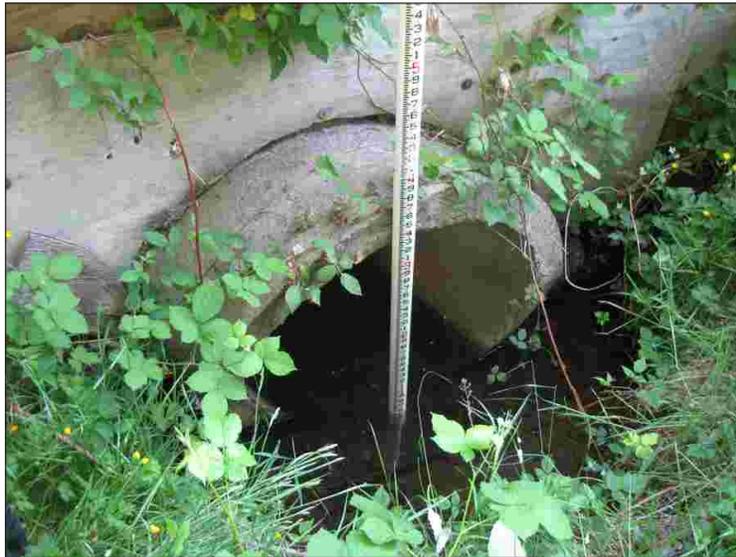
Station 59. South Branch of George Davis Creek 14,275 feet upstream from Lake Sammamish Parkway (36" culvert inlet; SW corner of 8th ST and 228th Ave)

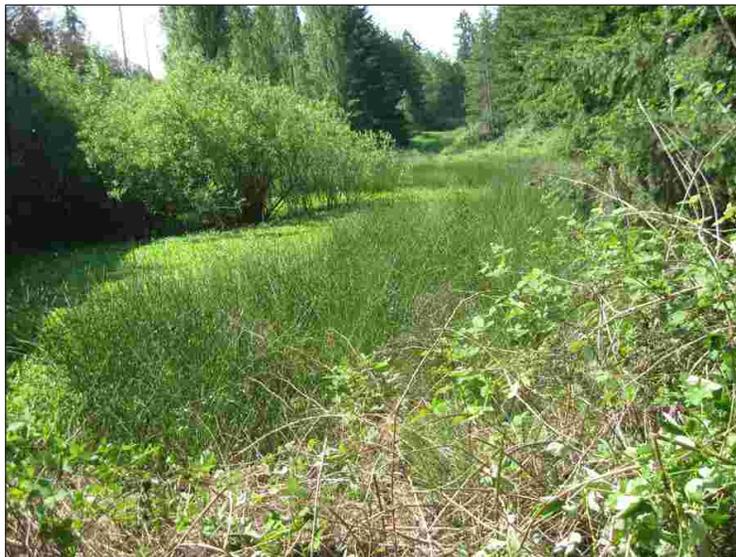
Station 60. South Branch of George Davis Creek 14,325 feet upstream from Lake Sammamish Parkway (upstream of culvert, no defined channel)

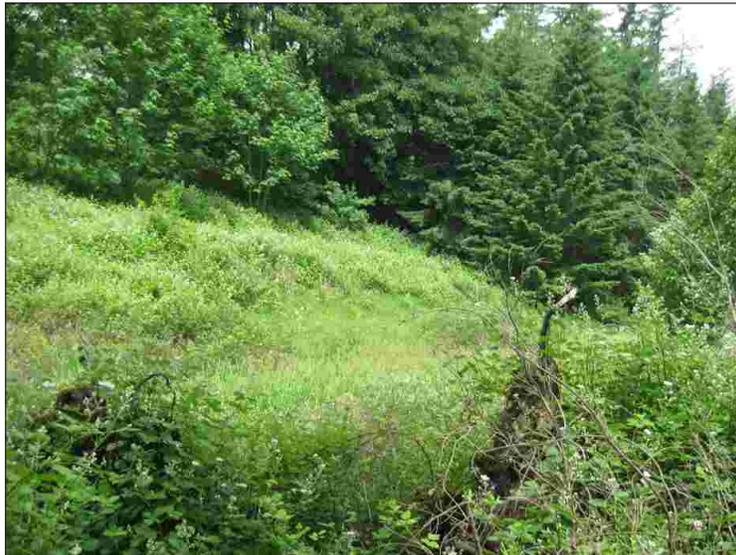
Station 61. South Branch of George Davis Creek 14,825 feet upstream from Lake Sammamish Parkway (looking DS from pond edge; uprooted trees fall uphill)

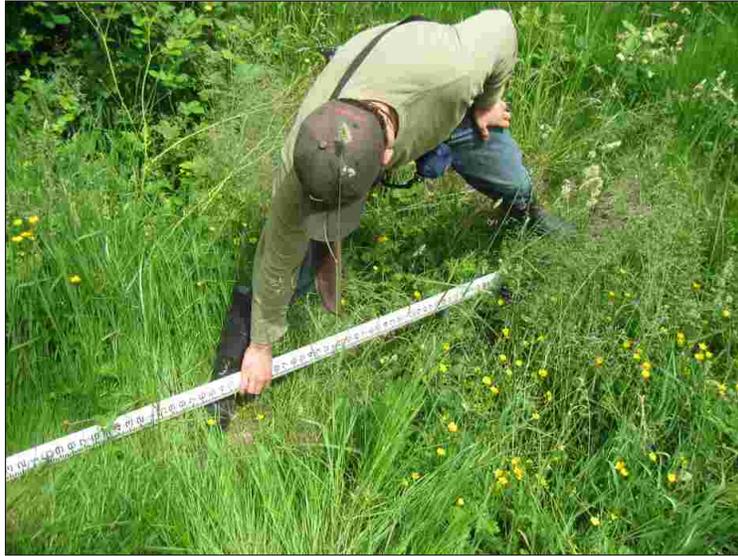
Station 63. South Branch of George Davis Creek 15,065 feet upstream from Lake Sammamish Parkway (deep rill 2.5' wide by 2' deep; off shore of pond)

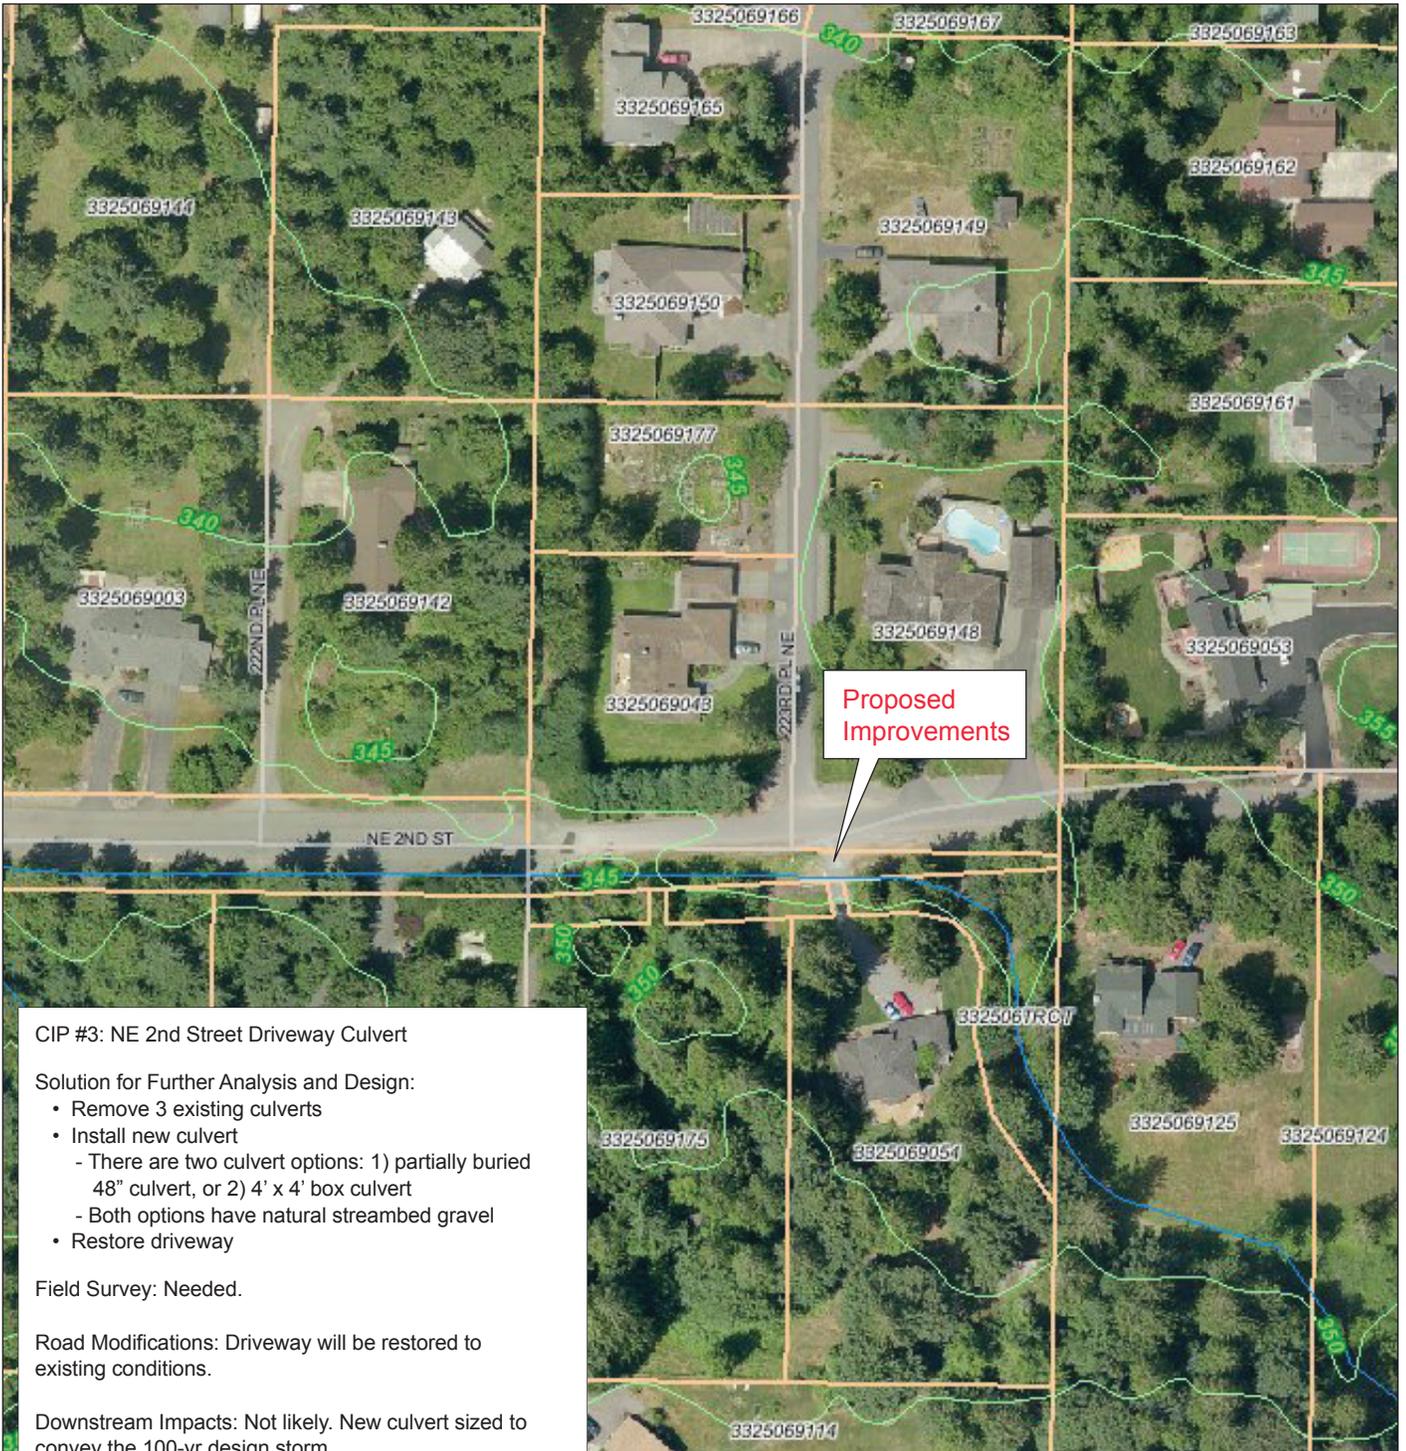
CIP #3: NE 2nd Street Driveway Culvert

Proposed Improvements

Road Modifications: Driveway will be restored to existing conditions.
