Appendix A Stream Assessment

PINE LAKE CREEK BASIN PLAN

То:	Toby Coenen, PE	Date:	December 16, 2024
From:			
	Peter Brooks, PE (NHC)	Erin Nelson, PE (Alta	aTerra)
Re:	Pine Lake Creek & Kanim Creek Stream Ass (NHC Reference No. 2007708)	sessments

1 STREAM ASSESSMENT

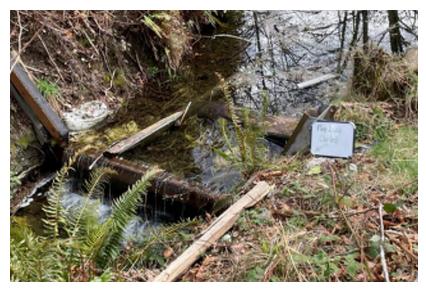
Photo 1. Pine Lake outlet weir looking upstream, STA 10900 (March 2023).

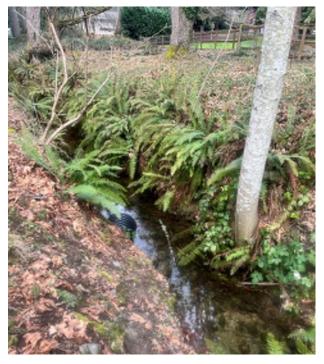
Approximately 20 feet downstream of the weir, an outfall discharges to Pine Lake Creek from the southwest (Photo 2). This is the outlet from the Pine Lake Bypass Structure, which was constructed to divert runoff from the bog area to the south around Pine Lake to reduce phosphorus loading and improve lake water quality.

Photo 2. Pine Lake Creek immediately downstream of weir, looking downstream at bypass outfall (March 2023).

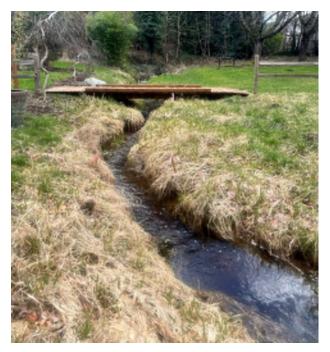
between the weir and 210th Avenue SE. Our visit indicated that maintenance is needed on the mitigation site to control invasive plants, such as reed canary grass. Photos 3 and 4 show the stream and wetland before it re-enters roadside ditches along SE 24th Street and 212th Avenue SE. Photo 5 shows the channel in the ditch adjacent to SE 24th Street.

Photo 3. Mitigation site at the SE corner of SE 24th St and 212th Ave SE, looking upstream STA 10200 (March 2023).

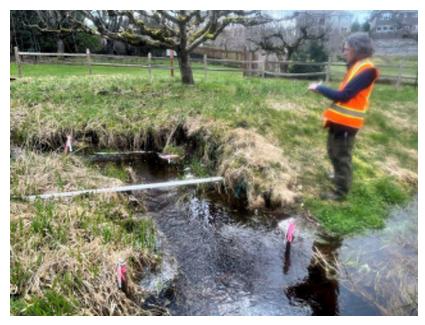
Photo 4. Mitigation site at the SE corner of the intersection of SE 24th Street and 212th Ave SE, where channel becomes braided through wetland, STA 10100 (March 2023).

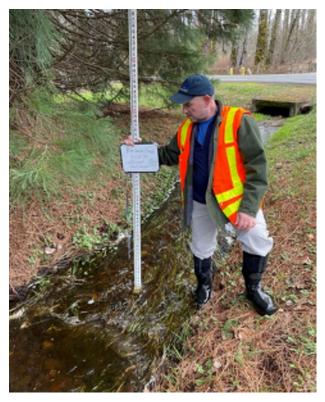
Photo 5. Pine Lake Creek in roadside ditch on south side of SE 24th Street, downstream of mitigation site. Looking downstream, STA 10000 (March 2023).

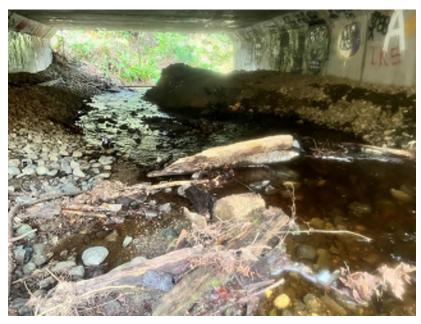
Photo 6. Looking downstream under 210th Place SE bridge, STA 8450 (March 2023). Notice the mound of sediment next to right wall at the downstream end of the bridge.

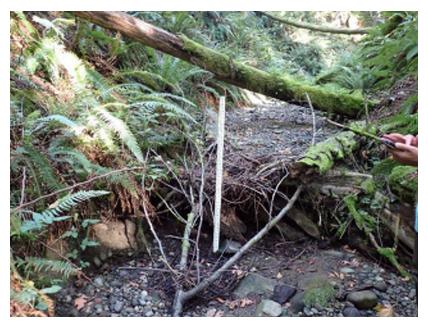
Photo 7. Large boulders and wood forming step pool features in steeper reach of Pine Lake Creek at STA 7500, downstream of 210th Place SE (September 2023), looking upstream direction.

During the September 22 streamwalk, the channel in the upper ravine was dry, though isolated wetted pools were observed. The upper ravine has a relatively uniform average slope of 4% (Figure 2a) below STA 7500. Between 210th Place SE and STA 7500, the channel has step-pool characteristics, with wood and large boulders forming channel steps (Photo 7). In addition to isolated wetted pools, water was observed in the channel between STA 7100 and STA 7300, likely from groundwater input at the interface of advanced outwash sand and underlying fine deposits (Photo 8). On the right bank near STA 7500, a narrow (about 1- to 2-foot wide), incised

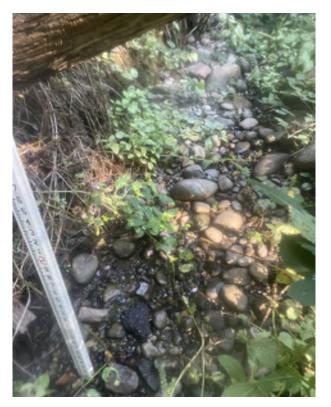
Photo 8. Water in channel observed between STA 7100 and STA 7300 (September 2023).

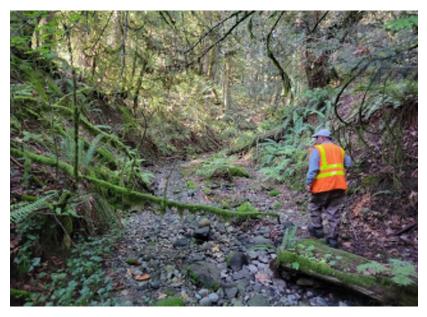
Through the upper ravine, Pine Lake Creek is deeply incised 10 to 15 feet into the adjacent hilly terrain, forming an over-widened U-shaped stream corridor (Photos 9 and 10). Downstream of STA 7500, channel bottom width ranges from 5 to 12 feet with a plane-bed morphology. The bed composition is poorly sorted cobble, small boulders, and gravel materials. Overall, ravine banks appear relatively stable, anchored by vegetation. However, vertical faces composed of varying assemblages of till and outwash materials were also observed. A single slump was observed along the right bank near STA 5800 (Photo 11).

Photo 10. Upper ravine channel and corridor, facing downstream, near STA 6400 (September 2023).

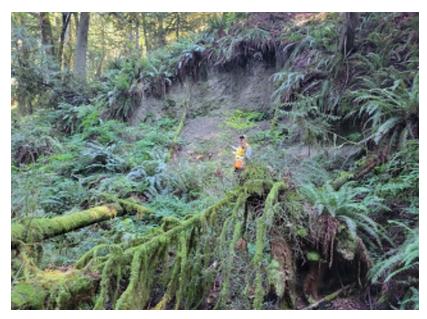
Photo 11. Slump on right bank of upper ravine channel, near STA 5800 (September 2023).

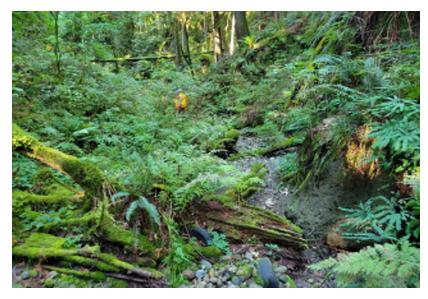
Photo 12. Large woody material (LWM in upper ravine facing downstream, near STA 5700. Note narrower low flow channel, remnant tire grade control (bottom center), and vertical bank composed of cemented till (bottom, right) (September 2023).

Although the corridor is surrounded by a second-growth mixed conifer and deciduous forest, relatively few pieces of large woody material (LWM) were observed in the channel. This may be attributed to a combination of low recruitment rates through treefall or bank erosion, larger tree size, and difficulty for larger LWM to come into contact with the incised channel (see Photos 9 and 13). Where LWM was observed, the channel appeared to be narrower, with a bankfull width more consistent with the stream size. Buried wood was also observed in the channel, as well as old tires (Photo 12). The latter are likely remnants of historic grade control features.

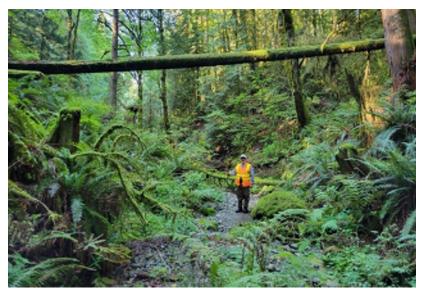
Photo 13. Example of treefall not interacting with stream channel. Looking downstream direction, near STA 5600 (September 2023).

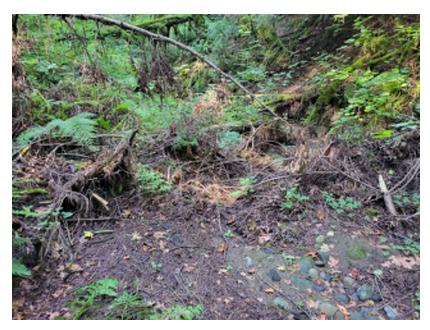
Photo 14. LWM debris jam, facing downstream, near STA 5500 Note, upstream sediment build-up (in foreground) (September 2023).

Despite the steep gradient, sediment loading in this reach appears to be moderate owing to the already over-widened channel corridor. Accumulations of finer gravel and sand-sized materials were observed above a LWM jam near STA 5500 (Photo 14).

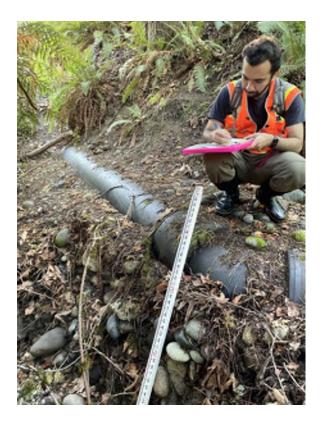
Photo 15. Stormwater outfall pipe and gabion dissipation structure on left side of channel looking upstream. Outfall pipe discharges stormwater from Stormwater Pond D92929 at STA 8400 near 210th PI SE (September 2023).

Several stormwater outfalls discharge to the upper ravine reach. Photos 15 and 16 show outfalls from stormwater ponds that serve The Crossings at Pine Lake development. Both outfalls appeared to be in good conditions without any signs of stream bank or bed erosion in the vicinity of the discharge points. A 12-inch corrugated metal pipe discharges from Pond D91443 on the left bank of the channel near STA 7050 (Photo 17). One private driveway road crossing (SE 19th St) spans the middle of the upper ravine reach at STA 6950. This crossing consists of a 7-to 8-foot-wide corrugated metal pipe (CMP) arch structure. Near-vertically placed logs, two to three feet high, provide grade control at the outlet of the culvert, behind which fine gravels are deposited forming a plane bed (Photo 18). According to the WDFW Level A Culvert Assessment report completed 10/31/2012, this culvert is a partial barrier and was rated 33% passable. The reason for the partial barrier rating was because of the water surface drop at the outlet of the culvert.

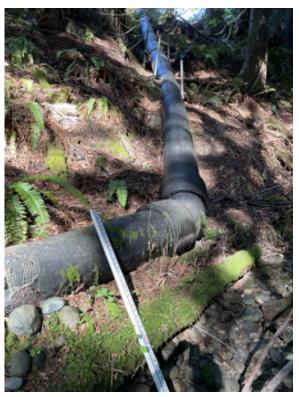
Photo 16. Right bank stormwater discharge pipe from Pond D92928, STA 7800 (September 2023).

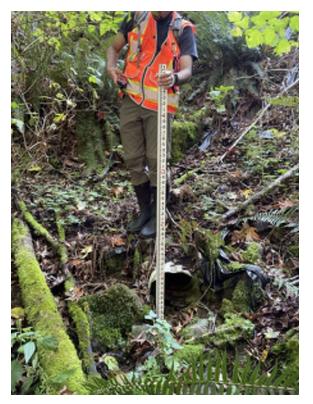
Photo 17. Left bank stormwater outfall that discharges from Stormwater Pond D91443 near STA 7050 (September 2023).

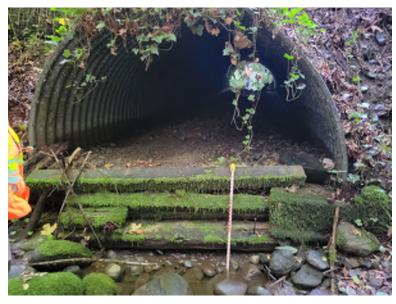
Photo 18. SE 19th Street private driveway culvert at STA 6950, looking upstream (September 2023).

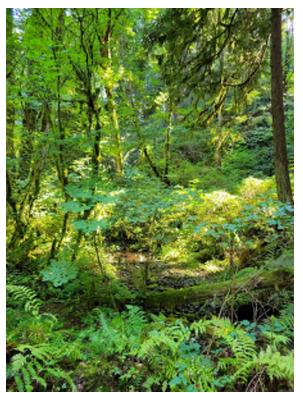
Less confined than upstream, the lower ravine sub-reach is moderately incised into either an historic alluvial fan or mass wasting deposits. The reach averaged slope is approximately 3%. Typical stream conditions near the upstream limit of the lower ravine are shown in Photo 19. Banks generally range from 2 to 6 feet high and are heavily vegetated and relatively stable. The stream continues to show a plane-bed morphology, though small pool-riffle-type sections were also observed (Photo 20). Bed composition in the lower ravine is slightly finer than that observed upstream, consisting mostly of large gravel and cobble particle sizes.

Photo 19. Pine Lake Creek channel corridor, facing upstream, near STA 4000. Note, steeper terrain of upper ravine sub-reach in the background (September 2023).

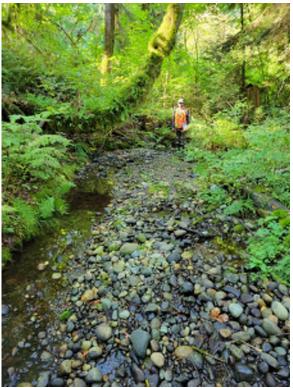
Photo 20. Plane-bed channel, with small pool, in the lower ravine sub-reach, facing downstream near STA 3600 (September 2023).

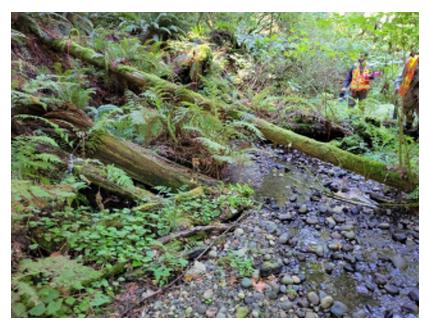
The frequency of LWM in the lower ravine appears slightly higher than the upper ravine. The slight increase in LWM frequency may be associated with the channel being less incised and thus more accessible to fallen timber (Photo 21). LWM recruitment still appears to depend mainly on the mortality of local, relatively mature trees since the channel lacks the capacity to transport LWM any distance downstream.

Photo 21. LWM in the lower ravine sub-reach, facing downstream near STA 3400 (September 2023).

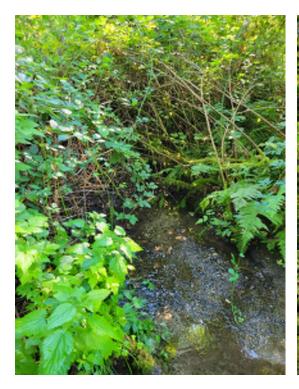
Photo 22. Channel in the upper wetland reach, facing upstream, near STA 2800 (September 2023).

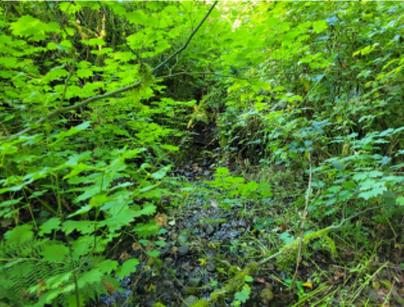
The dead trees suggest that this sub-reach is subject to frequent flooding. Photos taken upstream and downstream indicate abrupt fining of the streambed composition. What specifically initiated these conditions is uncertain, especially since the reach-averaged slope remains relatively steep (according to LiDAR). Localized backwater conditions originating downstream may cause flow to slow down, resulting in excess sediment deposition, flooding, and tree die-off. In turn, a positive-feedback loop could be initiated as a thick understory is allowed to grow, choke the channel, and result in more deposition. Alternatively, there could be unobserved manmade features in this sub-reach that are causing these conditions.

Photo 24. Upstream limit of the upper wetland reach, facing downstream, near STA 3300 (September 2023).

assessment of this sub-reach by a wetland scientist could help further define the quality and

function of the upper wetland.

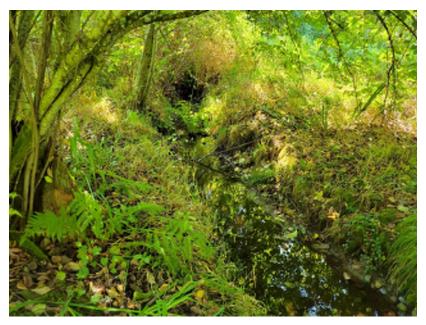
Photo 25. Channel near the upstream limit of the upper residential reach, facing upstream, near STA 2800 (September 2023).

generally low. The channel gradually becomes more incised in the downstream direction, with bank height on the order of two feet near the upstream end (Photo 25) and deepening to 3 to 5 feet downstream (Photo 26). A small low-lying wood pedestrian bridge spans the channel near STA 2650 (Photo 27). Bed material composition in this reach generally coarsens in the downstream direction, from sand to small gravels upstream, to gravel to small cobbles downstream. No evidence of fixed grade control, either natural LWM or manmade structures, were observed. Some active bank erosion was observed on the outside of a bend near STA 2500 and bank slumping near STA 2260 (Photo 26).

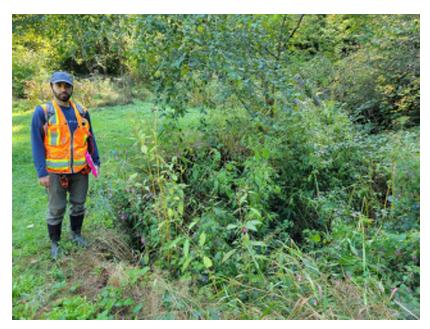
Photo 26. Thickly vegetated and incised channel (right) near the downstream limit of the upper residential reach, facing upstream, near STA 2260. Note, NHC personnel standing adjacent to scarp at slumped bank (September 2023).

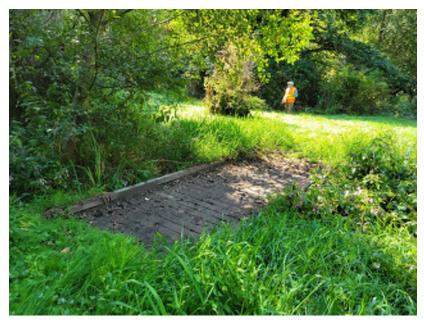
Photo 27. Small wooden pedestrian bridge over Pine Lake Creek in the upper residential reach, near STA 2650 (September 2023).

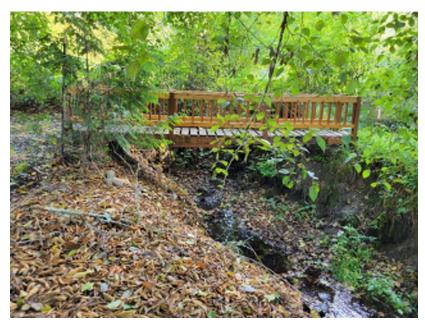
Photo 28. Small wooden pedestrian bridge over Pine Lake Creek in the lower residential reach, facing upstream, near STA 2260. Note channel incision and lack of vegetation (September 2023).

It is unclear if this lack of vegetation is due to landowner maintenance, a more mature canopy cover, erosive flows, or possibly all three. The channel corridor widens from approximately 10 to 25 feet in the downstream direction. Point bars were observed on the inside of meander bends. Actively eroding vertical banks were observed along much of the lower segment of the residential reach (Photo 29). In some locations, it was apparent that landowners were trying to stabilize banks with placement of small woody debris, wood or steel stakes, and erosion control fabrics (Photo 30). The channel generally maintains a pool-riffle morphology and is composed of coarse gravels and cobble-sized materials. The sub-reach is generally free of LWM. Three small pedestrian bridges cross the creek in this sub-reach (Photo 28).

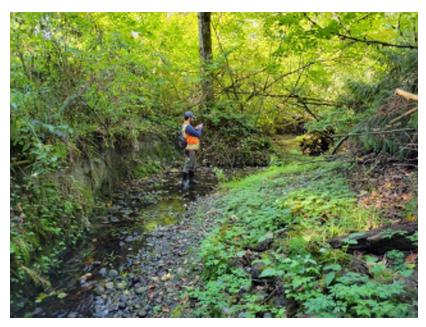
Photo 29. Widened channel corridor with vertical banks and point bar formation in the lower residential reach, facing downstream, near STA 2150 (September 2023).

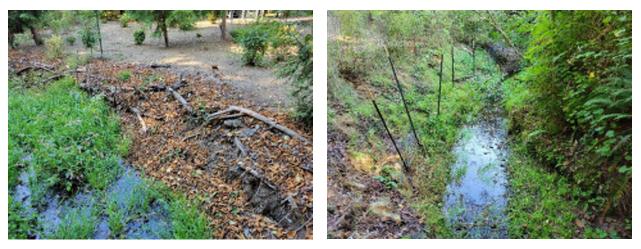
Photo 30. Bank erosion control measures placed by landowners in the lower residential reach (September 2023).

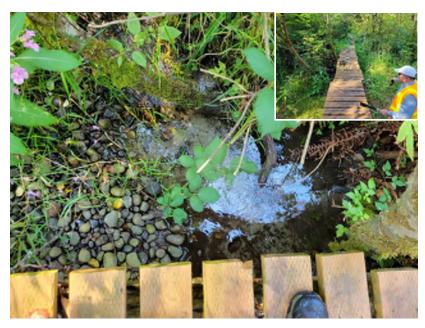
Photo 31. Bed material composition at a small wood pedestrian bridge crossing the assumed mainstem of Pine Lake Creek in the lower wetland sub-reach near STA 1500, and view of the bridge (inset) facing south (September 2023).

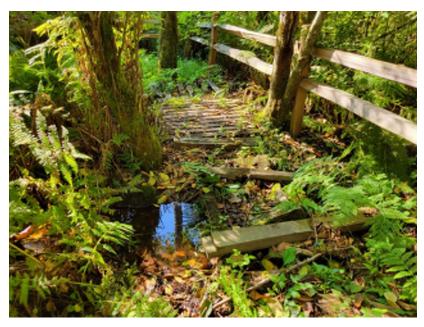
Photo 32. Channel braid crossing landowner constructed boardwalk, in the lower wetland subreach approximately 100 feet west of STA 1500 (September 2023). Stream Assessment, Draft December 2024

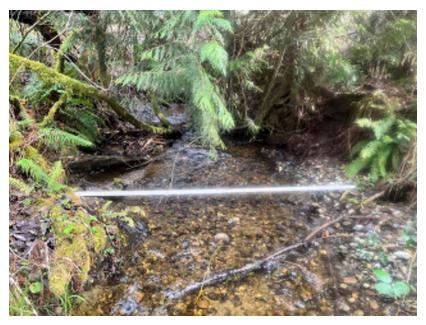
Downstream, near STA 1350, a distinct single channel is more defined and has an average bankfull width of approximately 10 feet (Photo 33); however, in some locations the channel is narrower (5 feet) and moderately incised 2 to 3 feet below the adjacent floodplain (Photo 34). Bed composition coarsens ranging from small gravel to cobble-sized material. The channel generally follows a step-pool morphology. Small gravel and sand bars are formed on the inside of bends with a fair amount of LWM observed in the channel (Photo 35).

Photo 33. Pine Lake Creek near STA 900, looking upstream (March 2023).

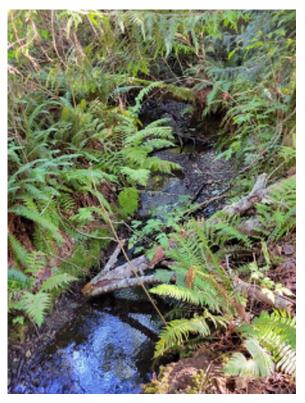
Photo 34. Moderately incised channel in the lower wetland sub-reach, facing upstream, near STA 1200 (September 2023).

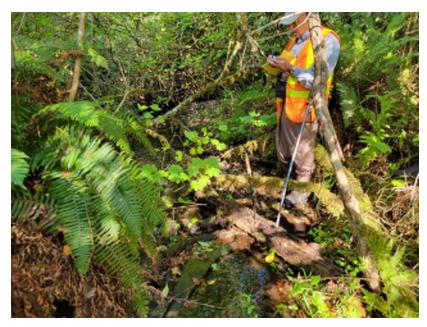
Photo 35. LWM observed in the lower wetland sub-reach near STA 1300 (September 2023).

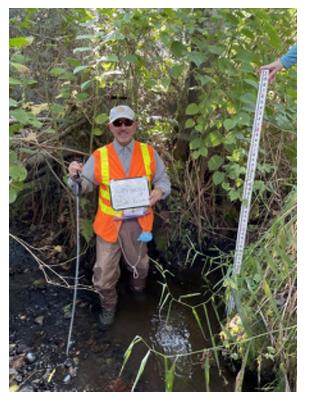
Photo 36. Confluence of Pine Lake Creek and Kanim Creek, near STA 800 (September 2023).

The downstream-most reach of Pine Lake Creek extends about 800 feet from the confluence with Kanim Creek (Photo 36) to the mouth at Lake Sammamish. The stream channel is incised immediately upstream of East Lake Sammamish Parkway, and bank erosion was observed on the right bank (Photo 37).

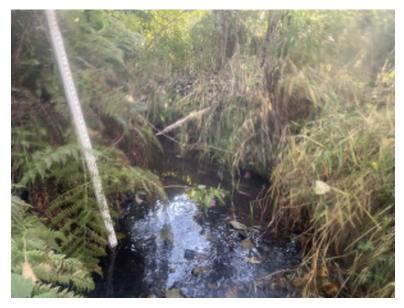
Photo 37. Incised channel upstream of East Lake Sammamish Parkway, looking upstream, near STA 700 (September 2023).

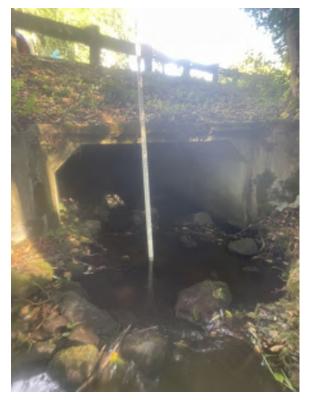
The reach is highly modified downstream of East Lake Sammamish Parkway (ELSP) and is dominated by culvert crossings at ELSP (Photo 38), East Lake Sammamish Trail (Photo 40), and Shore Lane (Photo 42 and Photo 43). The channel sections upstream of the trail and downstream of Shore Lane are highly modified with an engineered rock-controlled step pool morphology (Photos 39 and 44); the section between the trail and Shore Lane has few large rocks or wood and is relatively straight (Photo 41). The trail culvert was recently replaced and is now fish passable, but the Shore Lane culvert remains a partial passage barrier as listed by WDFW.

Photo 38. East Lake Sammamish Culvert, looking downstream, STA 600 (September 2023).

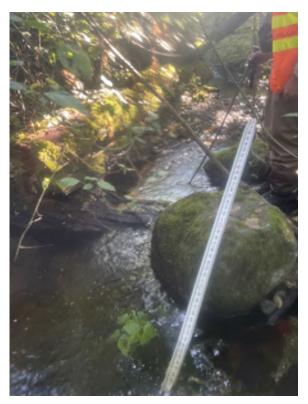
Photo 39. Boulders in channel between East Lake Sammamish Trail and East Lake Sammamish Parkway (September 2023).

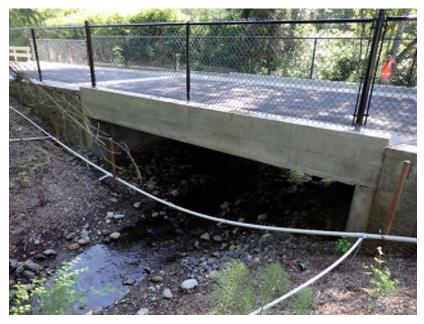
Photo 40. East Lake Sammamish Trail culvert, looking north (September 2023).

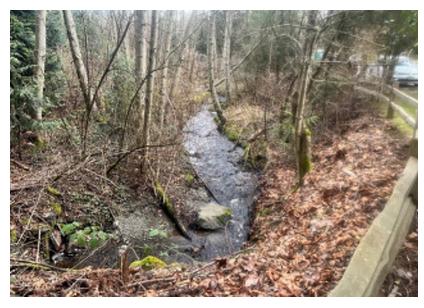
Photo 41. Section between Shore Lane and East Lake Sammamish Trail, looking upstream (March 2023).

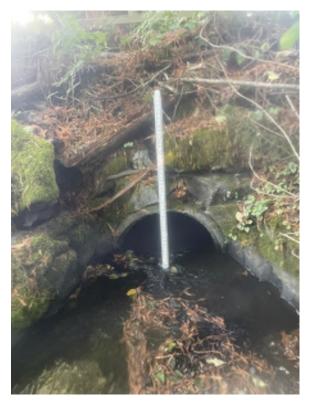
Photo 42. Shore Lane culvert (September 2023). Looking upstream.

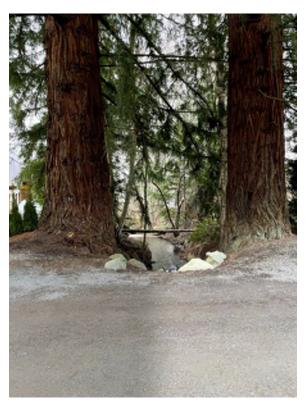
Photo 43. Shore Lane crossing looking downstream between two redwood trees (September 2023).

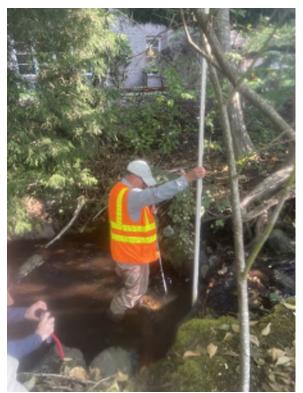
Photo 44. Downstream of Shore Lane, pool downstream of wood sill, near STA 200 (September 2023).

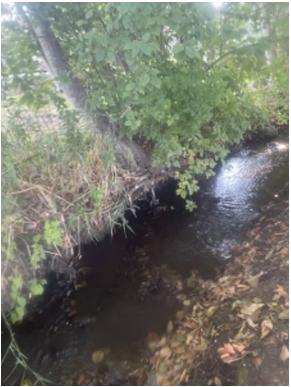
The lower reach supports perennial flow, with continuous flow observed even in late September. The channel at the mouth is shown in Photo 45.

Photo 45. Pine Lake Creek immediately upstream of mouth, STA 100 (September 2023).

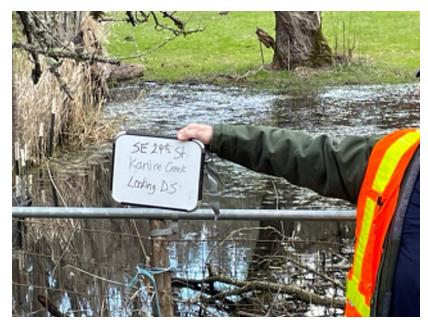
Photo 46. Kanim Creek headwaters at SE 24th Street, STA 5100 (March 2023).

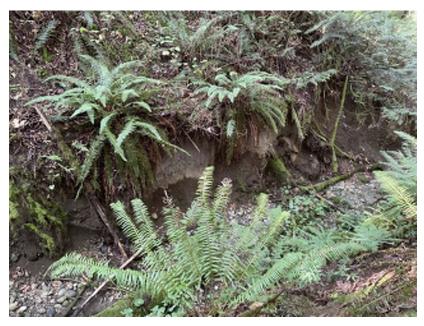
Kanim Creek is deeply incised downstream of the SE 19th street crossing (up to 6 or 7 feet). It remains incised until approximately STA 2500, where the channel flattens out and significant aggradation has occurred. Photo 47 shows an example of channel incision observed in Kanim Creek. Photo 48 shows an active left bank hillslope failure near a stormwater outfall. Photo 49 shows deposition in a December 2019 photo. The stream channel is not confined to a single thread in this area and is braided across the deposition zone until it re-forms a single thread incised into the thick sediment downstream at approximately STA 2200 (Photo 50).

Photo 47. Channel incision in Kanim Creek near STA 3200 (September 2023).

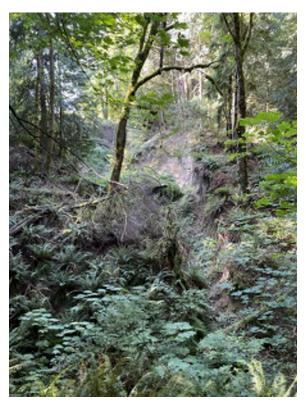
Photo 48. Hillslope failure near stormwater outfall on left bank near STA 3100 (September 2023).

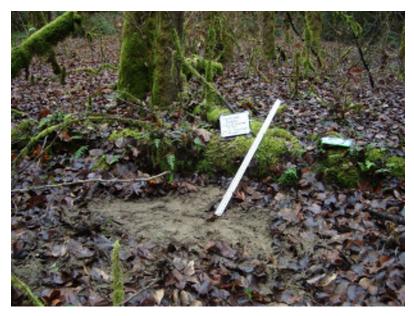
Photo 49. Deposition of sand observed near STA 2200 (December 2019).

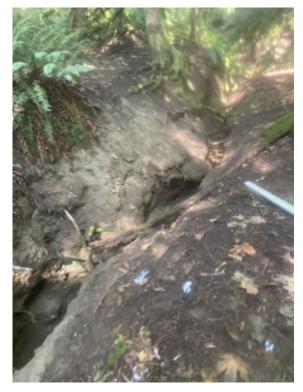
Photo 50. Deep incision into deposited sediment on downstream end of deposition zone, near STA 2750 (September 2023).

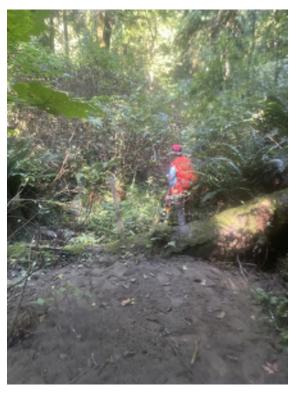
At the time of our September 2023 visit, there was no standing water in the channel upstream of STA 1500, however, some wet zones were observed where seepage was occurring on the banks. Photo 51 shows fine sand deposited behind a log sill near STA 1500. Water was observed in the channel around STA 1500 and the channel started to have wetland-like characteristics. Kanim Creek was not walked between STA 1500 and STA 1000 due to difficult terrain and accessibility.

Photo 51. Fine sand deposited behind log sill near STA 1500 (September 2023).

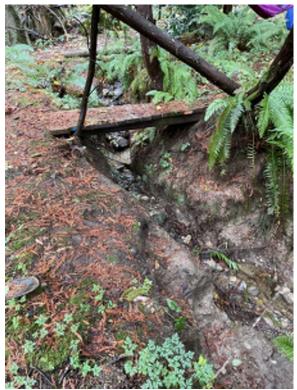
A stormwater facility on the north side of SE 19th Street discharges to the roadside ditch on SE 19th before entering Kanim Creek. Photo 52 shows the incised channel that has formed downstream of the stormwater outfall. This erosion has the potential to worsen and contribute to water quality issues in Kanim Creek.

Photo 52. Channel formed downstream of stormwater outfall from Stormwater Facility D92924.

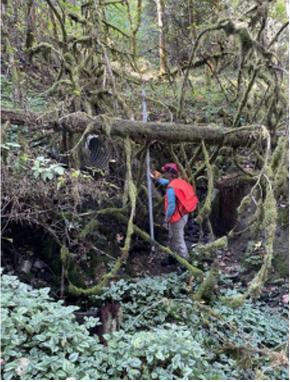
Downstream of SE 19th Street, the creek flows through a deep ravine, with active landslides, erosion, and deposition. Three culverts (two conveying Kanim Creek, and one conveying stormwater) are located at the head of the ravine and are perched several feet above the channel floor. Photo 53 shows the culverts.

Photo 53. Perched culverts conveying Kanim Creek at SE 19th Street, STA 3800 (September 2023).

No aquatic species were observed in Kanim Creek during the streamwalk. The lower wetland reaches were not walked but would be expected to provide similar habitat conditions to the lower wetland sub-reach of Pine Lake Creek. Upstream of the wetland, the steep incised channel and ephemeral flow conditions do not provide suitable habitat for fish species and likely present a natural passage barrier. The SE 19th Street culverts are not fish passable.

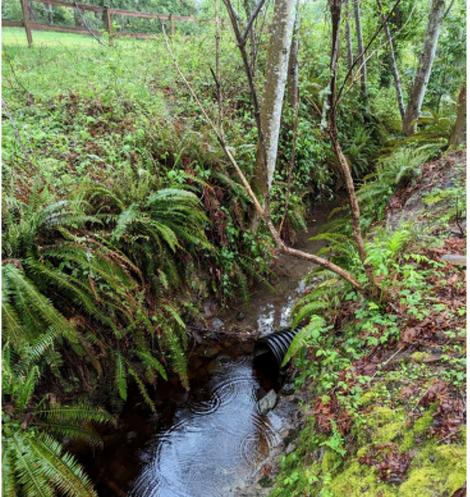
Photograph 1. PLC Upper sample location between pipe and weir.

is via a path through the stormwater facility; and flow and water quality measurements were taken upstream of the stormwater outfall (Photograph 1). Under low flow conditions the exact position of the flow measurement varied depending on channel conditions, but the water quality samples and measurements were always collected upstream of the stormwater outfall.

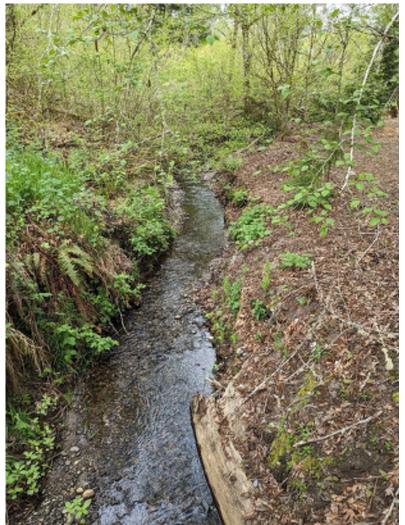
Photograph 2. PLC Lower sample location looking downstream from bridge.

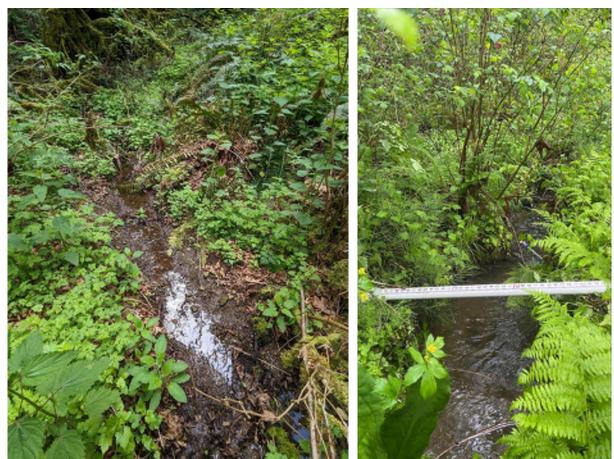
Photograph 3. Kanim Upper channel upstream of SE 19th Street.

Kanim Upper is located in the upper region of the Kanim Creek basin. This sampling site (Photograph 3) represents the headwaters of Kanim Creek and is accessed from SE 19th Street just west of 202nd Pl SE via a faint trail on the right bank on the upstream side. Water quality and flow measurements were intended to be collected if stream conditions allowed, but due to the stream being too shallow or dry during this study, no samples were collected from this site.

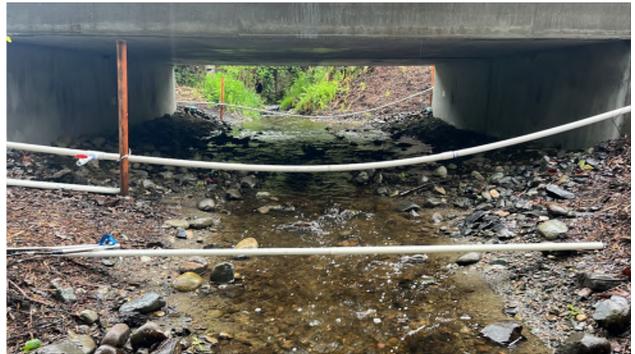
Photograph 5. PLC Outlet sample location looking upstream.

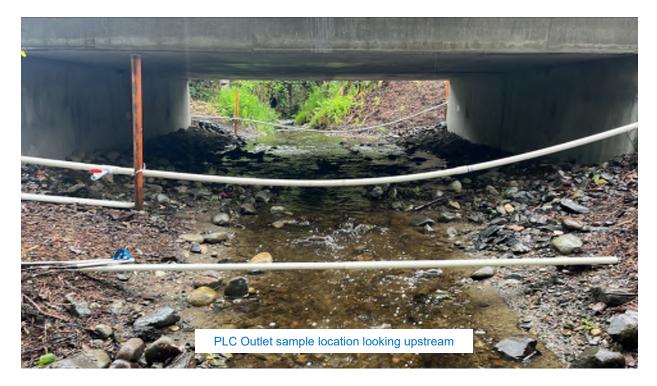
PLC Outlet is in Pine Lake Creek below the confluence of Pine Lake Creek and Kanim Creek. This site is intended to measure the flow and water quality conditions of the entire basin just upstream of where the creek flows into Lake Sammamish. Access is just downstream of East Lake Sammamish Trail from East Lake Sammamish Shore Lane SE. Use care to ensure you stay off of private property near the site. The best reach for flow and water quality measurements is just downstream of the trail bridge.

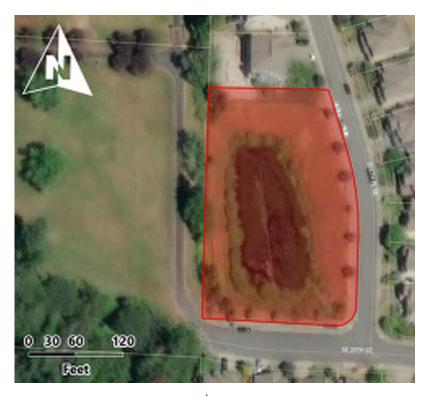
Plan View

Ideal design will maintain/reuse established foliage and pond infrastructure to the extent feasible.

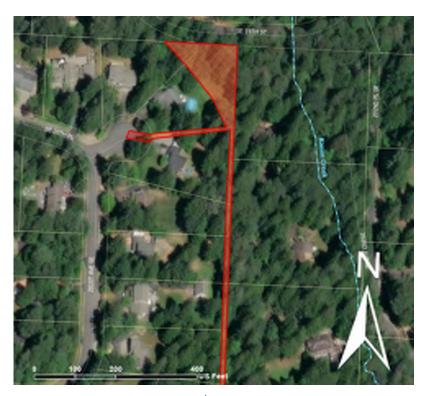
Plan View

Stormwater outfall has noticeable erosion and overflow, with downstream excessive peak flows. Updated detention infrastructure is proposed to reduce peak flows during storms, reduce erosion, and improve water quality.

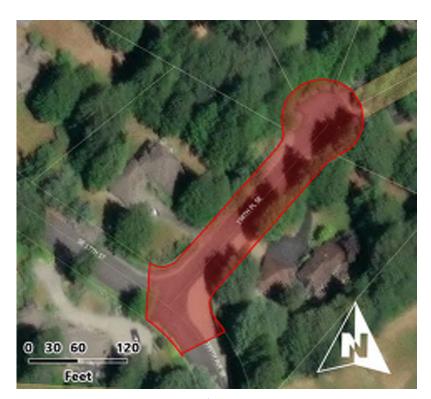
Plan View

This project retrofits the street edge with a bioswale. This bioswale will include foliage and rock to assist with erosion control along the shoulder, provide water quality treatment, and enhance the aesthetics of the street edge. Bioswale is designed to include detention to the extent feasible.

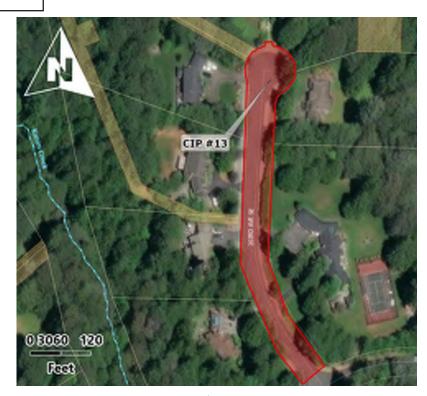
Plan View

This project retrofits the street edge for low impact development by including a bioswale. This bioswale will assist with erosion control along the shoulder, provide water quality treatment, and enhance the aesthetics of the street edge.
