**Date:** May 8, 2026  
**To:** Randall Heeb, Opsis Architecture  
**Copy to:** Chris Roberts, Opsis Architecture  
**From:** Nick Bartish, WPIT, and Riley Plumb, PWS, Herrera Environmental Consultants, Inc.  
**Subject:** Wetland and Stream Reconnaissance for the City of Sammamish Building 120 Feasibility Assessment and Community Use Planning Project

| Figure 1. | Wetland Boundary Delineated for the Sammamish Building 120 Project. .... | 8 |

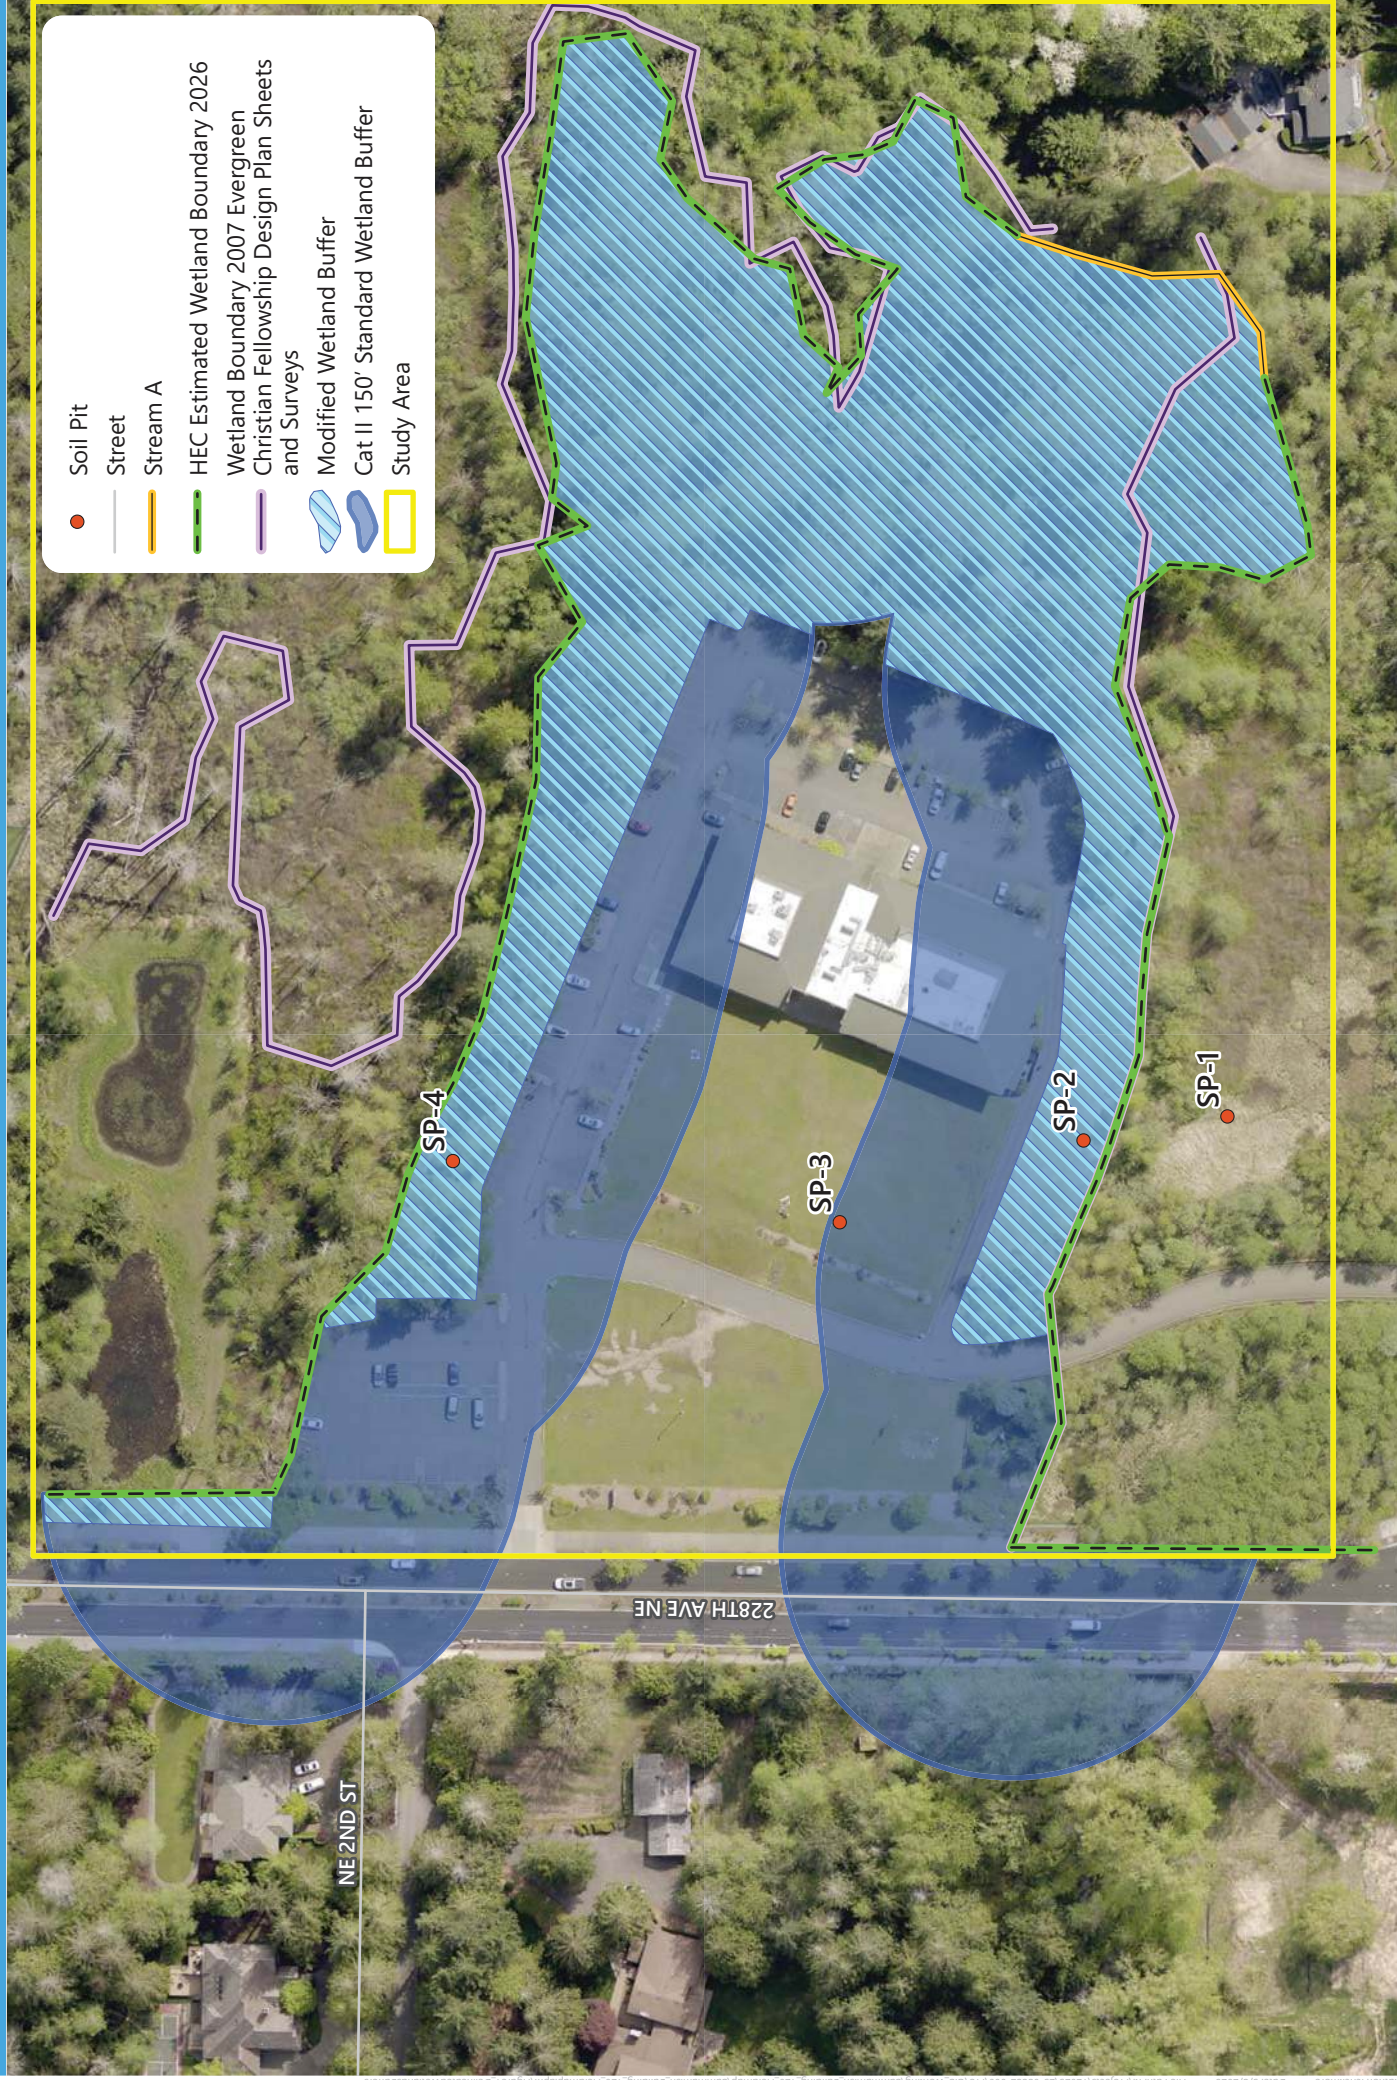
Biologists rated the entire wetland using observations collected during the field reconnaissance, and data from the NWI, Natural Resources Conservation Service (NRCS), and LiDAR. As summarized in Table 1, WLA received a total rating score of 22 points on the rating forms, which meets the criteria for Ecology's classification as a Category II wetland (Hruby and Yahnke 2023). The habitat score for WLA is 7 points. Estimated boundaries of WLA are shown on Figure 1.

Biologists noted the presence of one stream, Stream A, while walking the boundary of Wetland A (Figure 1). Stream A is an unmapped inlet to Wetland A that enters the wetland from the south near East Main Street. Stream A is approximately 2 feet wide and has a bed of cobble and silt substrate. Stream A has a gradient less than 16 percent which meets the criteria of a Type F stream under Washington Administrative Code (WAC) 222-16-031. Biologists did not observe fish within Stream A during site reconnaissance. Type F streams have a buffer of 150 feet SMC21.03.020 W.4.a.. Stream photos were collected and are available in Appendix C.

WLA's 150 ft buffer may be subject to modification as it interacts with the edge paved surfaces on parcel 3425069017 (Figure 1).

Development implications identified by Herrera during the reconnaissance-level site investigation are as follows: SMC 21.03.020 V.3.f. requires that a 1:1 mitigation ratio is applied to any impacts within protected wetland or stream buffers. New or redevelopment within the standard-width wetland and stream buffers will likely require buffer mitigation, unless modification due to interruption by the site's existing built areas and road surfaces is applied according to City code SMC 21.03.020 V.1.e.ix. If modification of the standard buffer is approved by the City, new or redevelopment within only those areas identified as "Modified Wetland/Stream Buffer" on Figure 1 would require buffer mitigation.

The City's standard buffer width of 150 feet to protect Wetland A is truncated by existing on-site development and adjacent roadways (Figure 1). The isolated buffer, separated from the non-impacted buffer, provides minimal functions to WLA. Excluding the isolated portion of the buffer that is constrained from performing proper buffer functions due to existing development, the City can modify the required buffer to an average of 55-feet on the northern end, and 53-feet on the southern end of the buffer, which will encompass only that portion of the remaining buffer where functions are being performed. Table 2 shows a comparison of buffer functions from the non-impacted buffer and the buffer that has been isolated by the existing roadway.

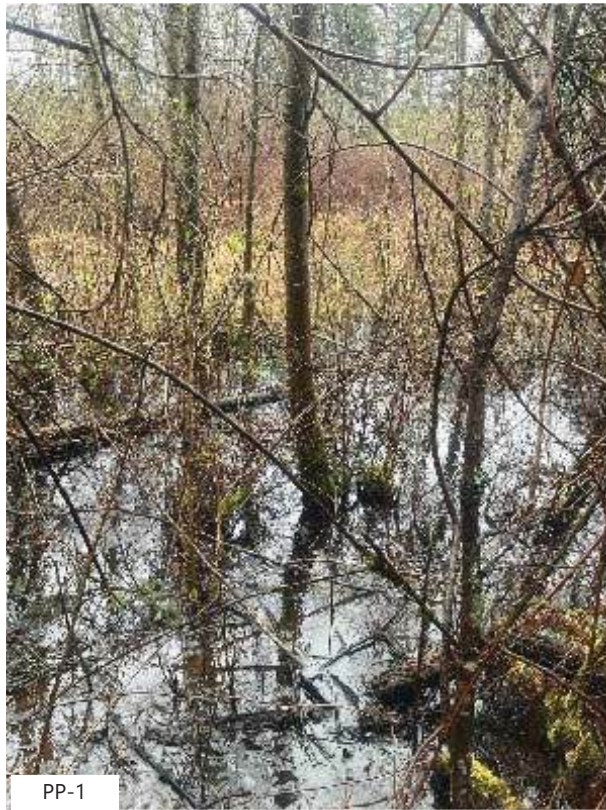
| Photo Number | Photo Description |
|---|---|
| PP-1 | Wetland conditions observed on the northern end of the study area. |

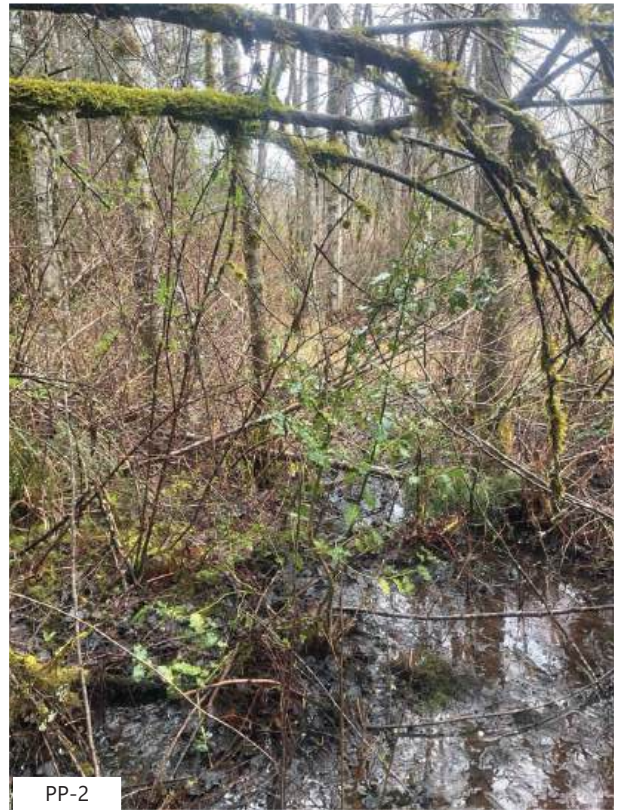
| Photo Number | Photo Description |
|---|---|
| PP-2 | Wetland conditions observed on the northern end of the study area. |

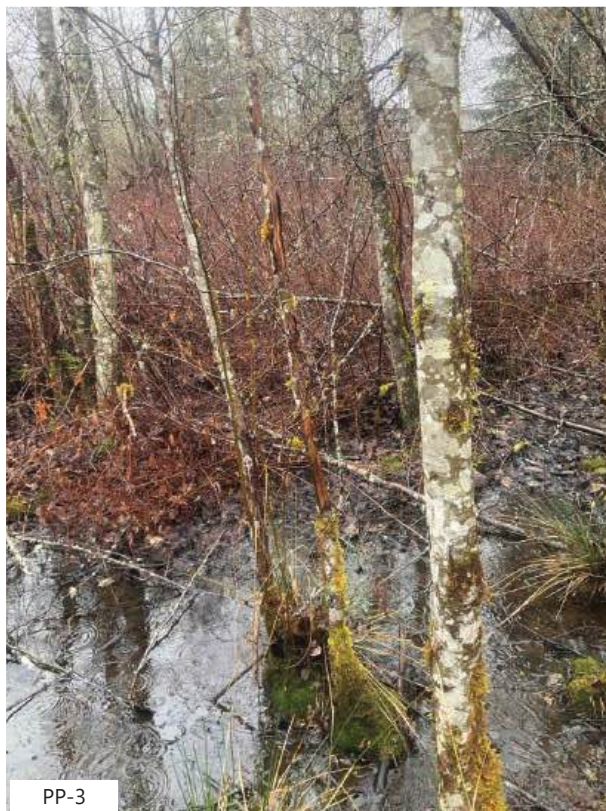
| Photo Number | Photo Description |
|---|---|
| PP-3 | Wetland conditions observed on the southern end of the study area. |

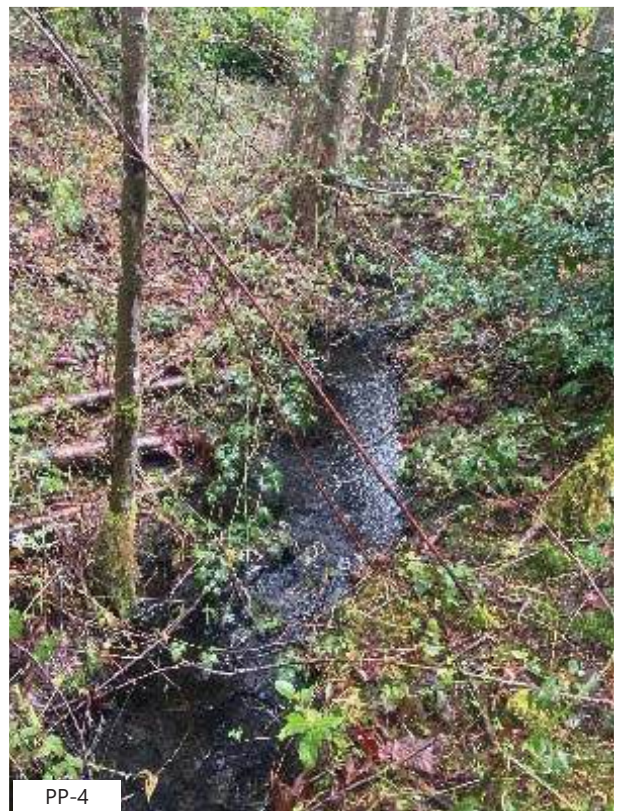
| Photo Number | Photo Description |
|---|---|
| PP-4 | Stream A. |

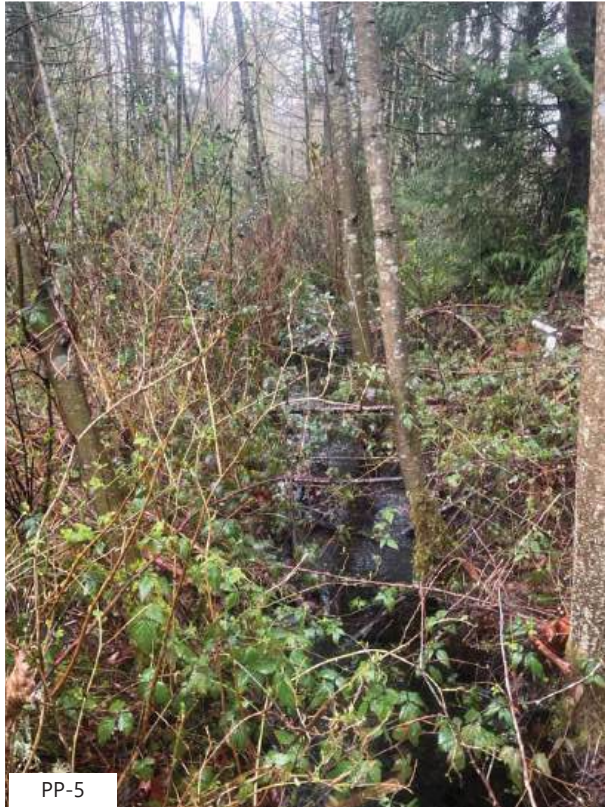
| Photo Number | Photo Description |
|---|---|
| PP-5 | Stream A. |
