City of Sammamish

# **BUILDING 120 – ASSESSMENT NARRATIVE**

April 10, 2026

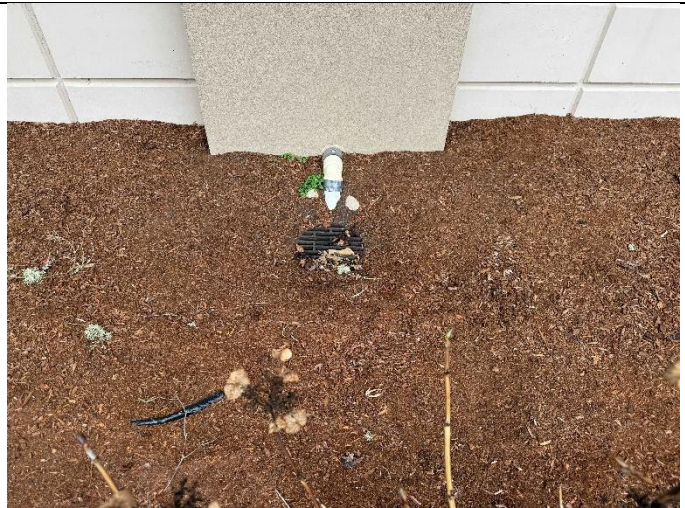
29. **Landscape mulch is too high on wall.**

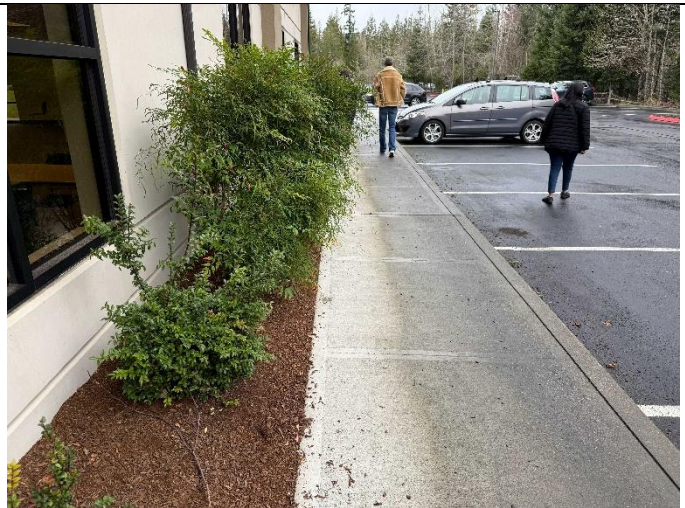
30. Note temporary wall infill.

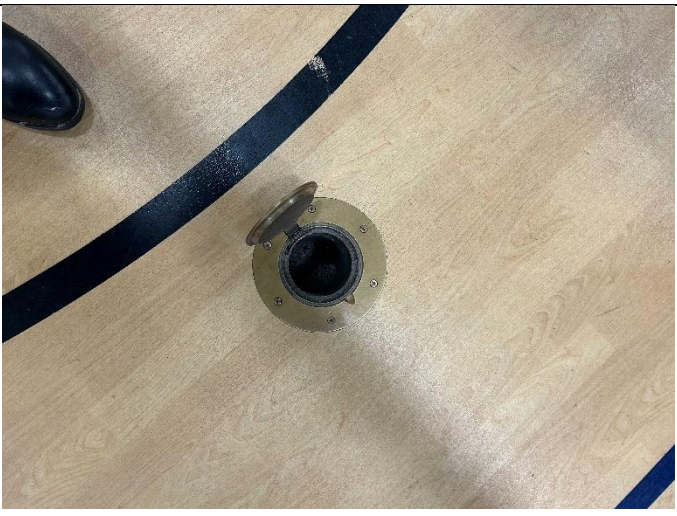
| <p>32. Confirm volleyball sleeves work.<br/>Are appropriate poles in storage?<br/><i>It is not clear why weighted poles are being used.</i></p> | |

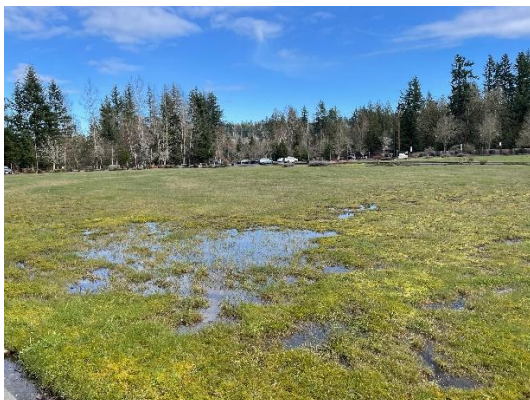
Large areas of lawn currently exist between the street and the building. They are very wet for much of the year, which limits usability. However, given the uncertainty on future use of the lawn areas, we do not recommend renovating lawn areas with grading and drainage work as a baseline.

*Example of ponding on lawn*

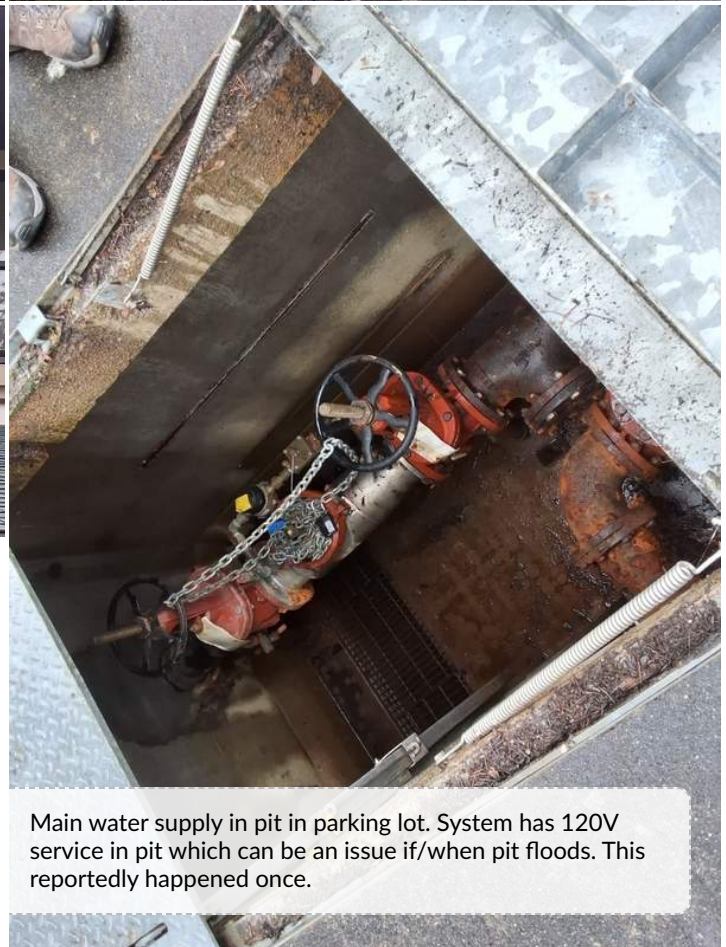
Main water supply in pit in parking lot. System has 120V service in pit which can be an issue if/when pit floods. This reportedly happened once.

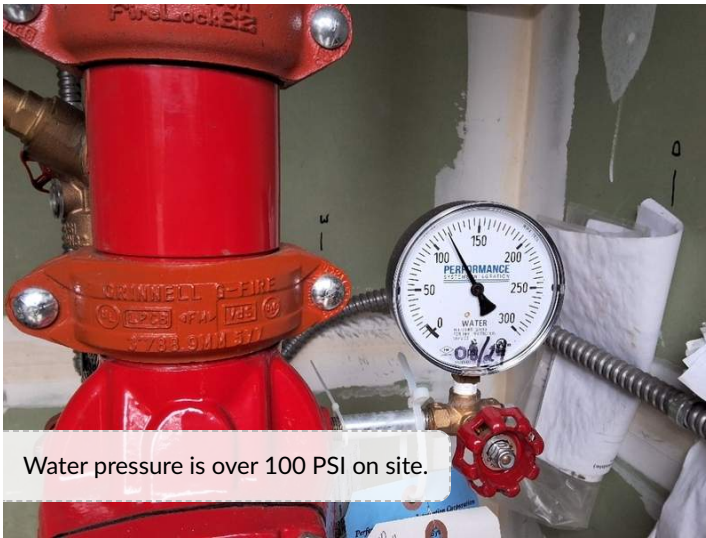
Water pressure is over 100 PSI on site.

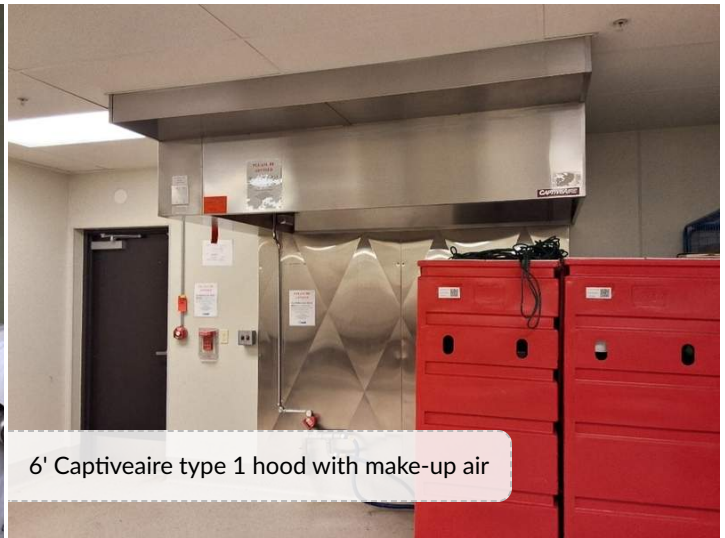
6' Captiveaire type 1 hood with make-up air

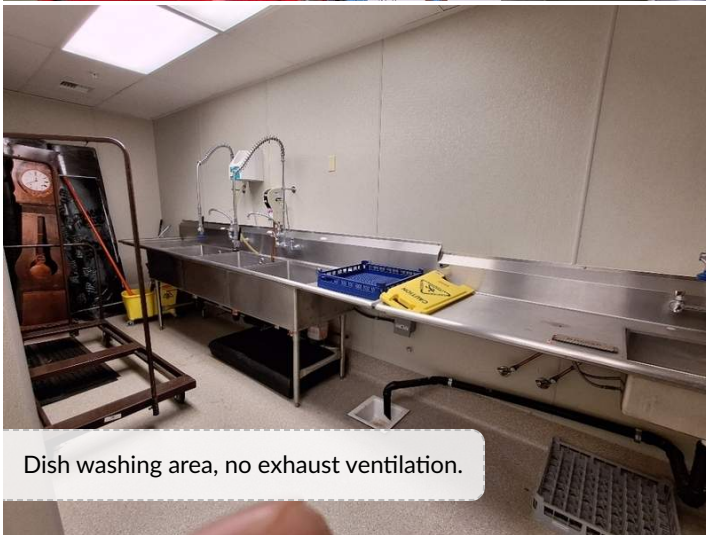
Dish washing area, no exhaust ventilation.

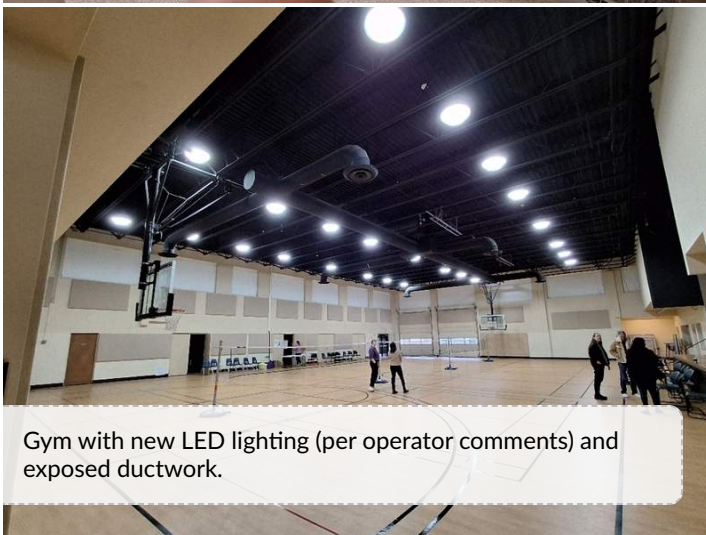
Gym with new LED lighting (per operator comments) and exposed ductwork.

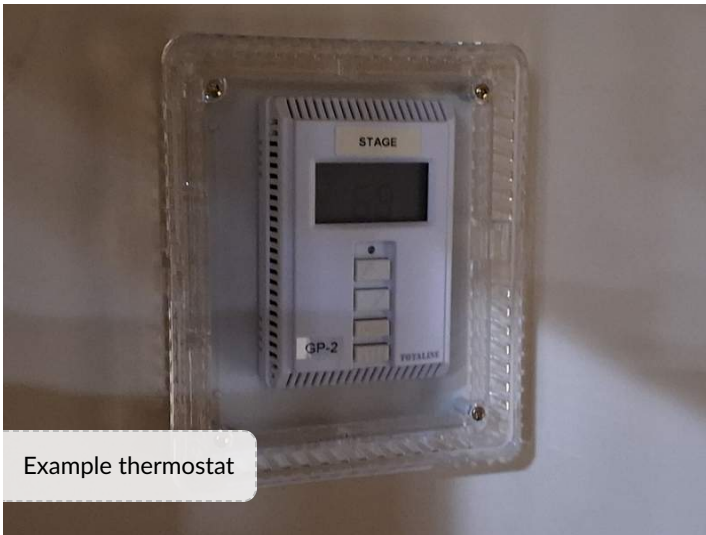
Example thermostat

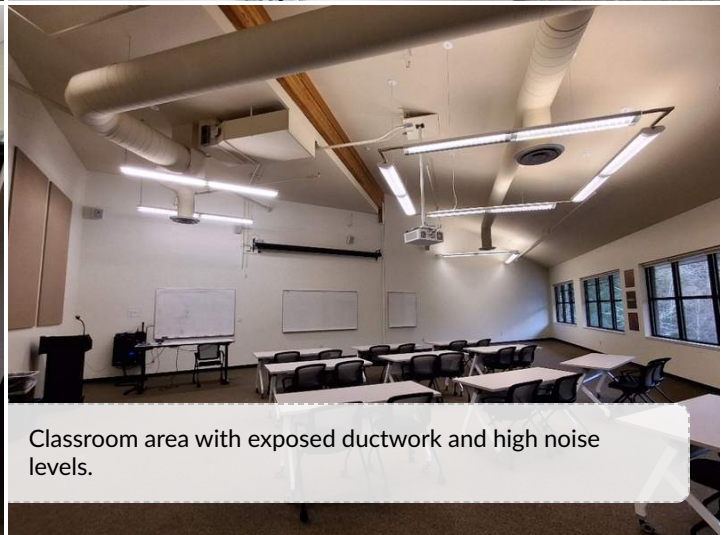
Classroom area with exposed ductwork and high noise levels.

High noise levels were observed in this area (typ of both classrooms). It is believed the sound is due to the diffuser coming directly off the main drop.

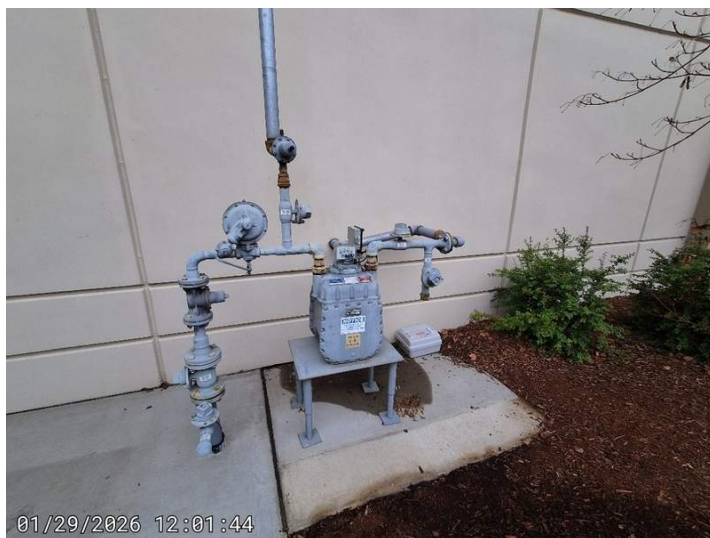
| <b>Deficiency or Issue</b> | Natural gas service doesn't have a seismic shut off. |
| <b>Risk of Failure</b> | 2- Medium |

| <b>Recommendation (to Resolve)</b> | Install seismic shut off valve as a best practice. |

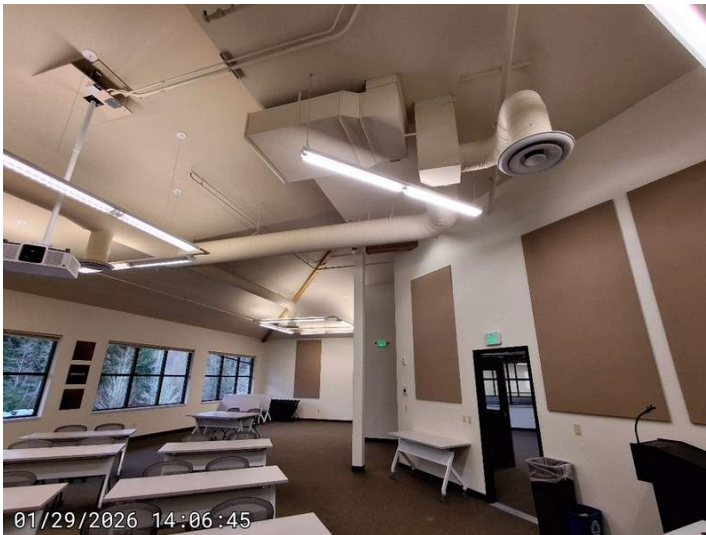
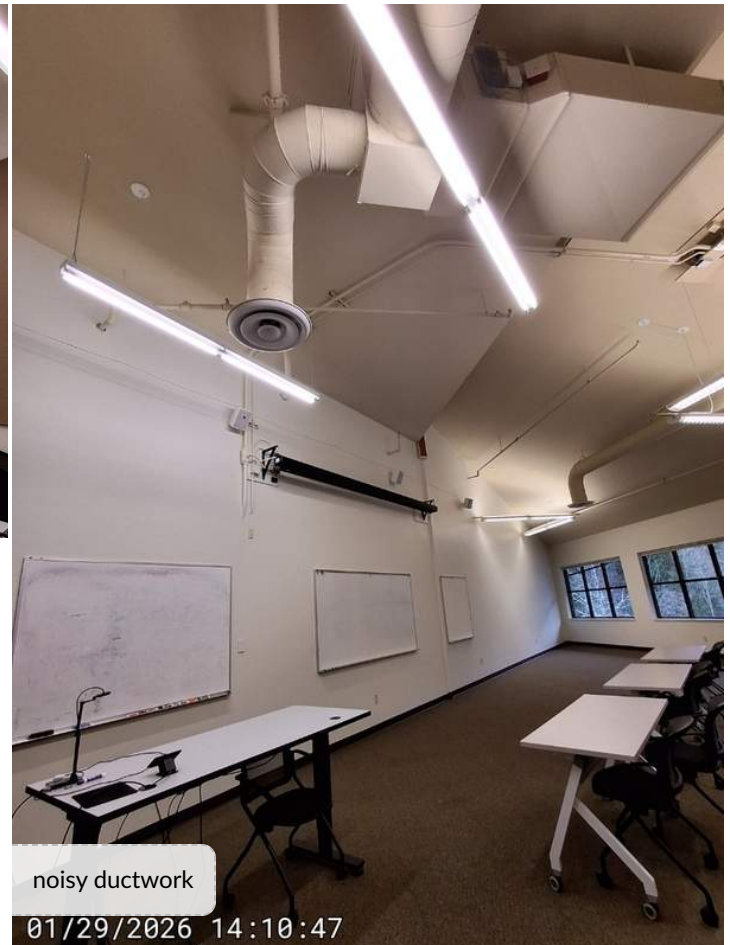
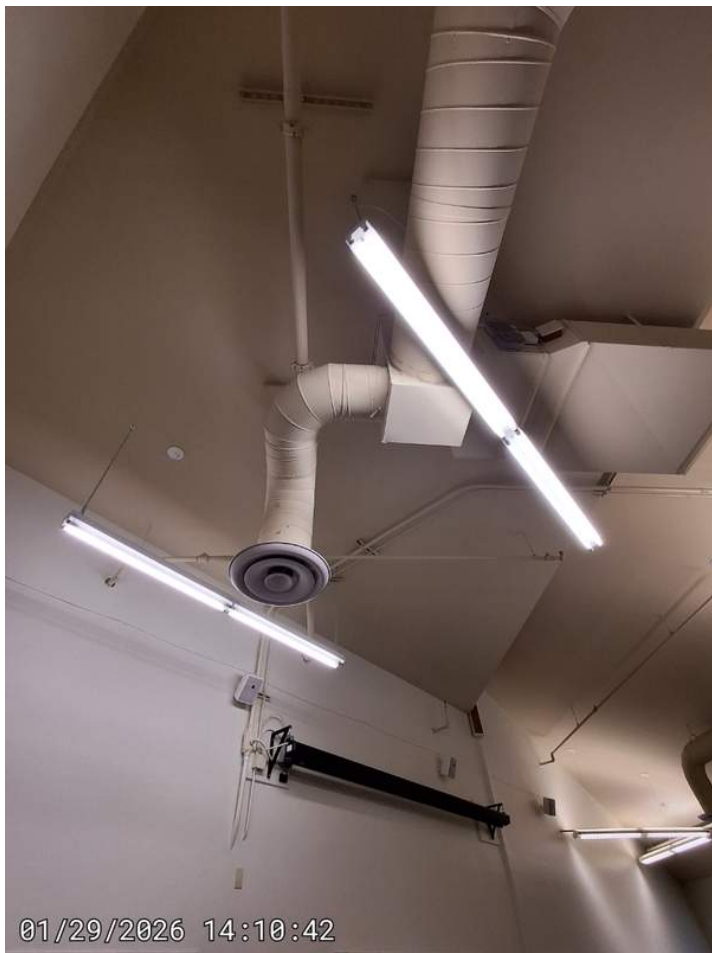
| <b>Condition</b> | Fair |
| <b>Deficiency or Issue</b> | Class rooms 201B and 201A has high noise levels due to ductwork distribution. |

| <b>Recommendation (to Resolve)</b> | Move supply air diffusers and revise system for reduced sound levels. |

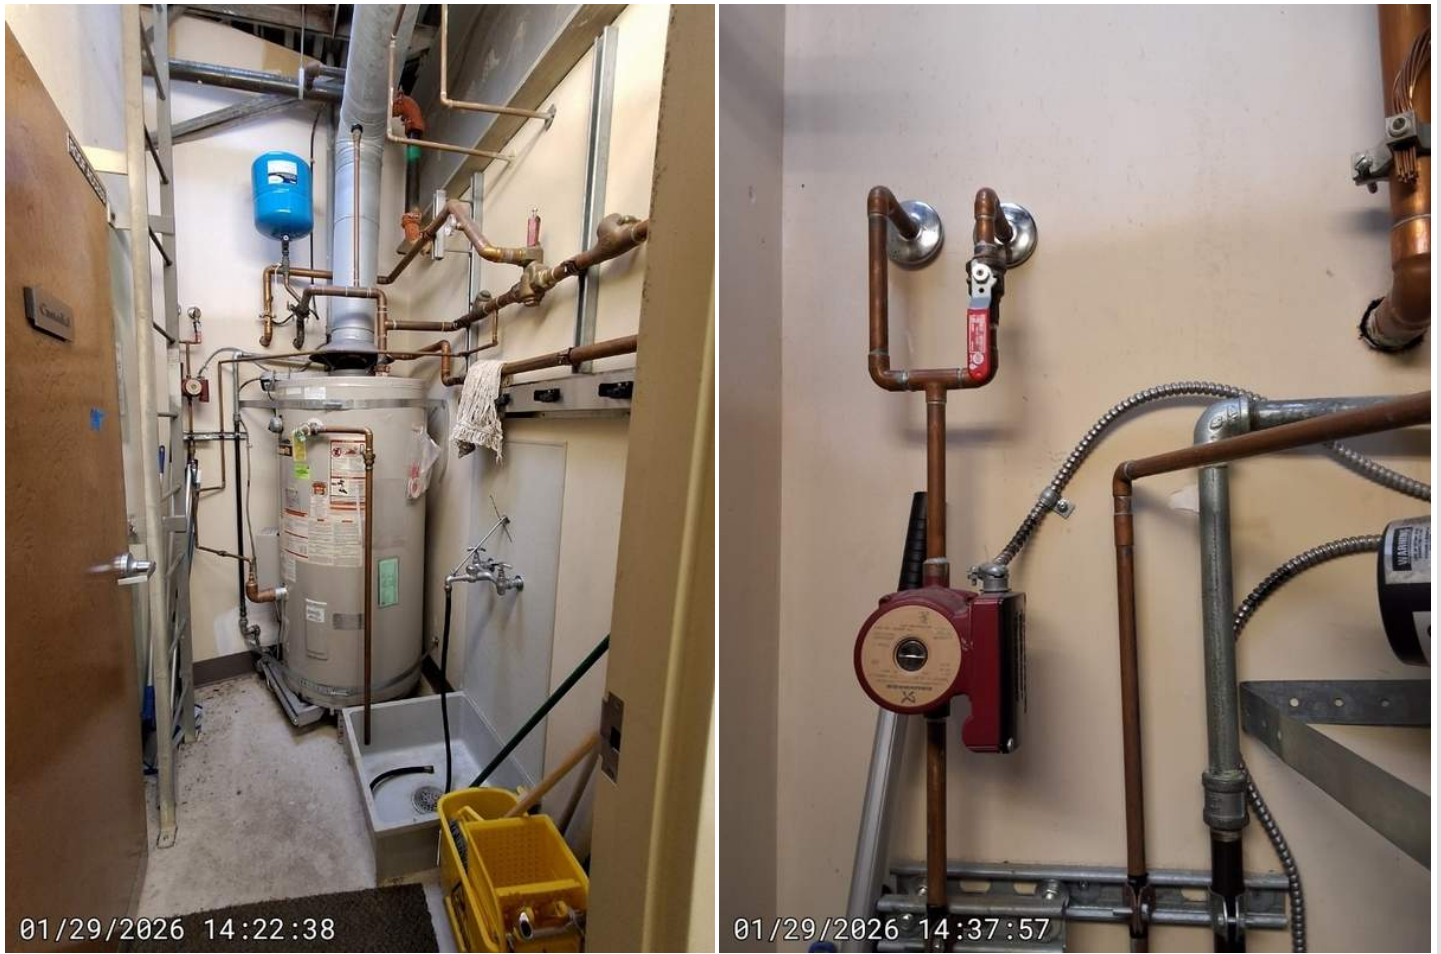
| Condition | Fair |
| Deficiency or Issue | Existing AO Smith non-condensing domestic water heater original to building and nearing end of life. |

| Recommendation (to Resolve) | Replace with new condensing unit |

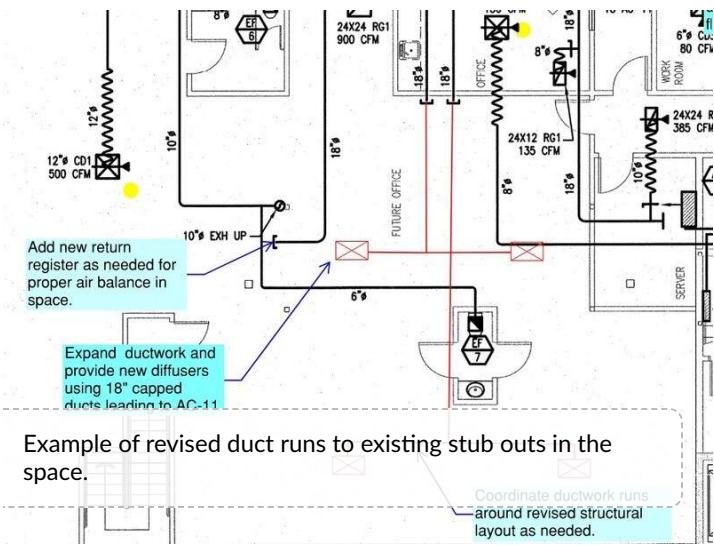
| <b>Condition</b> | Fair |
| <b>Deficiency or Issue</b> | Space is large with glass partitions breaking up space. However, there is only a single supply air diffuser serving the area. This will lead to heating and cooling issues when the space is utilized. |

| <b>Recommendation (to Resolve)</b> | Re-engineer HVAC in this space and add supply air registers to ensure proper air distribution. Note that the original construction team installed duct stub outs with the intention of expanding the ductwork to obtain proper air distribution on the first floor. Expanding the existing ductwork and re-balancing the airflows in the space, and AC-11, will be beneficial to occupant comfort. However, if large cooling loads are expected (such as the space becomes a large heavily used event space) Alternatively, convert to a make-up air unit and add DX ceiling cassettes if the space cooling load significantly increases. |
