**REVISED 60% REVIEW SUBMITTAL  
 NOT FOR CONSTRUCTION**

PROJECT NAME  
**EAST LAKE SAMMAMISH  
 MASTER PLAN TRAIL  
 INGLEWOOD HILL ROAD PARKING LOT**  
 SAMMAMISH, WA

**REVISED TREE PRESERVATION PLAN**

SHEET NO.  
 1 OF 1  
**TP1**

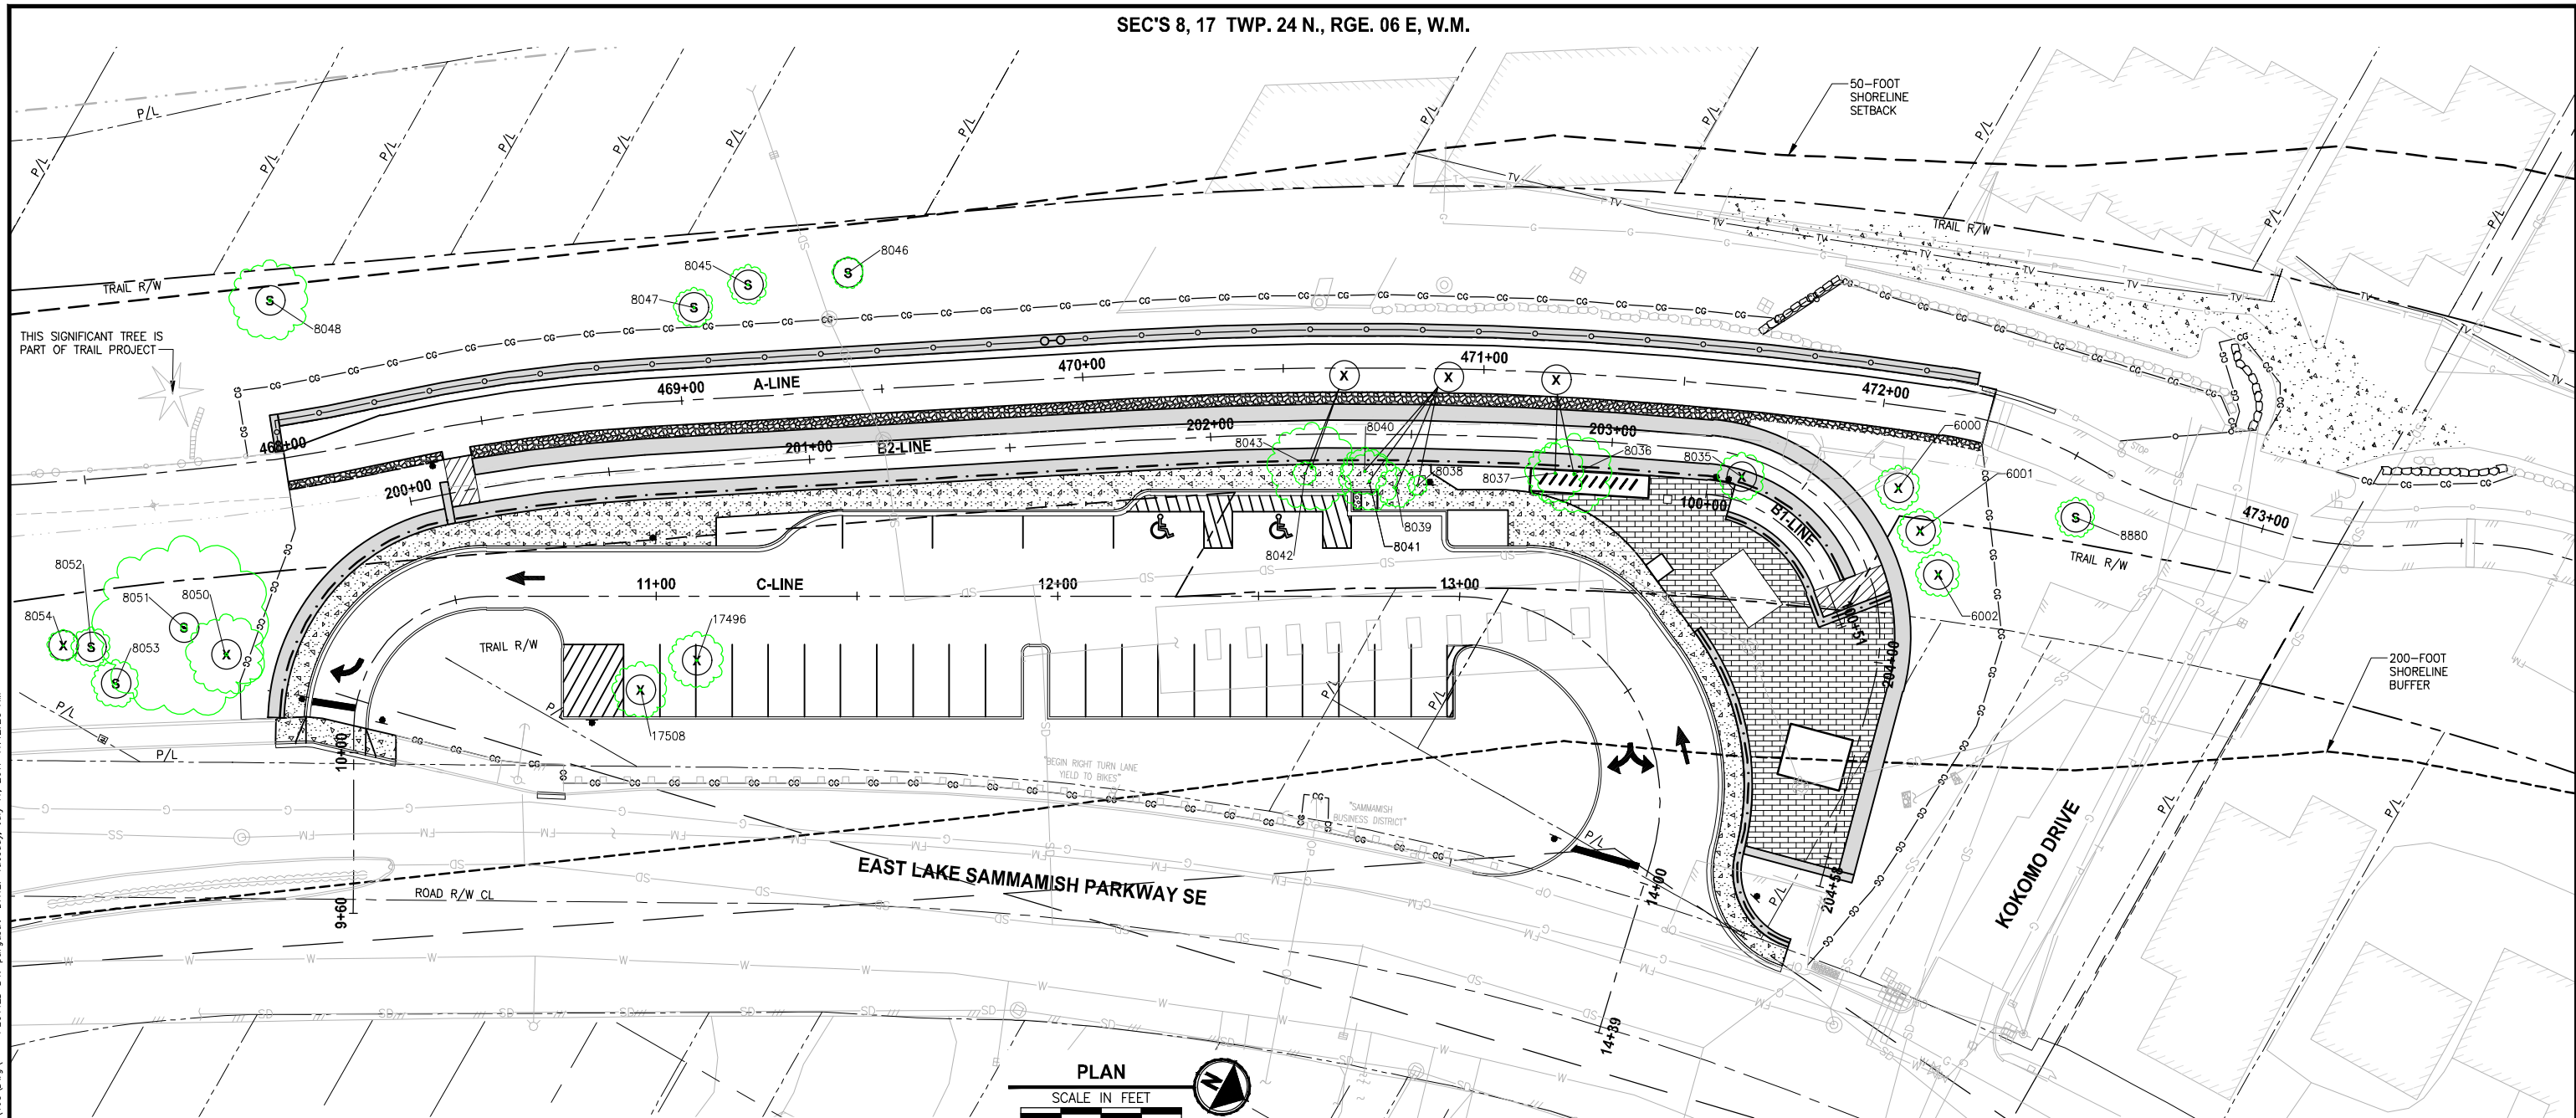
(S) SAVE  
(X) REMOVE

**NOTE:**  
 1. ASSESSMENT OF TREE RETENTION ON THIS PLAN IS BASED ON EXISTING CONDITIONS IN JULY, 2017.
